The retable of the chapel of Our Lady of Mercy in the cloister of Oporto's Cathedral: study, conservation and restoration

Patrícia Monteiro, José Carlos Frade, Carolina Barata, António Candeias

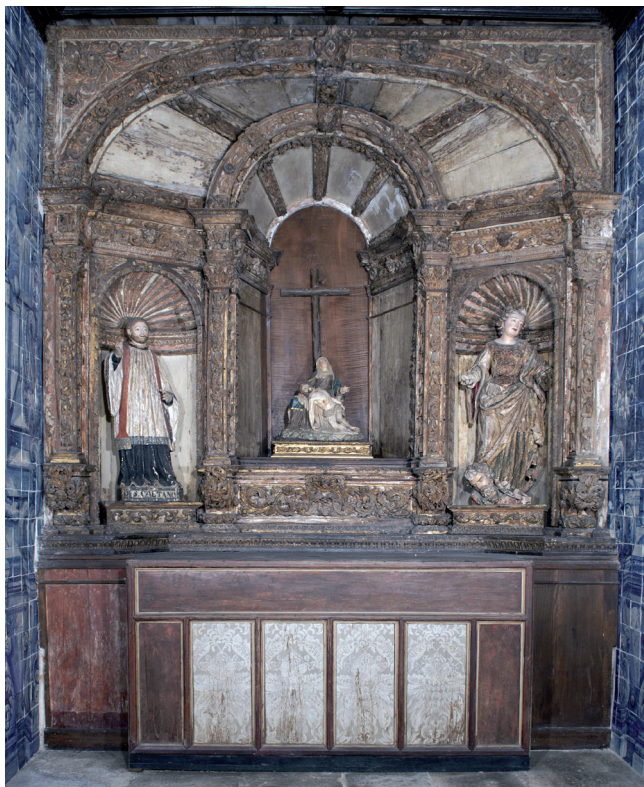
An initial observation acknowledged small holes in the wooden support, confirming the presence of wood-boring beetles' activity. Some of the structural elements showed evidence of fungal attack (brown rot) and the presence of salts (partially dissolved in water), which ascended

from the granite floor through the wood's capillaries. The polychrome and gilding layers (ground, colour, and Armenian bole) showed accumulated dust on the surface, signs of weakening of the binding medium and abrasive wear. Nearly 45% of the polychrome and gilded areas were affected by lacunae, as a consequence of fracture and detachment, causing visual disturbance.

A shine over the retable's surface evidenced a previous consolidation. In the niches, green layers of paint over the white-coated panels indicated an unsuitable chromatic inpainting. Several screws with signs of corrosion fixated the wooden panels and the carved decorative elements.

Figure 1.- The retable in the chapel of Our Lady of Mercy before the conservation treatment. Photographed by Patrícia Monteiro.

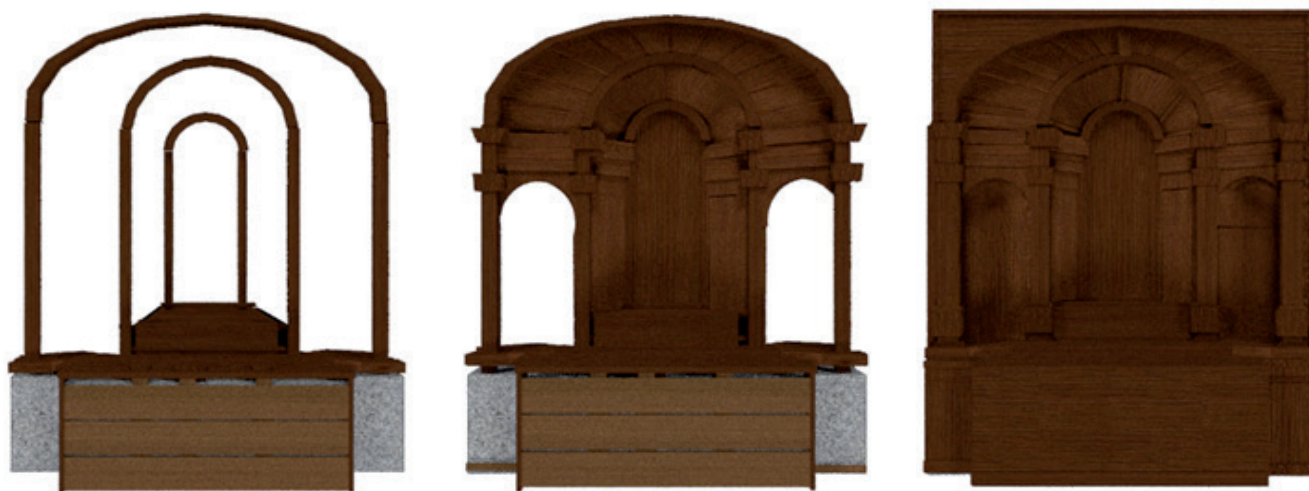
Figure 2.- Three-dimensional model representing the construction process of the retable. Created with the software *Autodesk Maya*; a) Arches' placing; b) Wooden boards nailed from the centre out; c) Wood structure's final appearance. 3D modelling by Patrícia Monteiro.

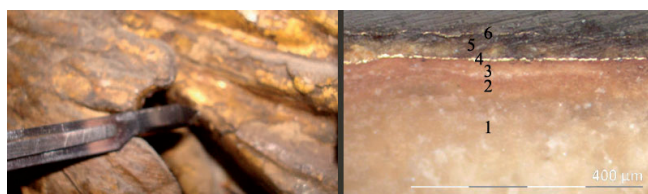
Figure 3.- a) Sample collected in the gilded predella; b) Cross-section (scale $400\mu\text{m}$). Identification of two gold layers (number 4 and 6). Photograph and image acquisition by Patrícia Monteiro.

The materials in the gilded areas seem to be original, except for the predella, where a sample evidenced a re-gilding with mordant over the previous gold leaf.

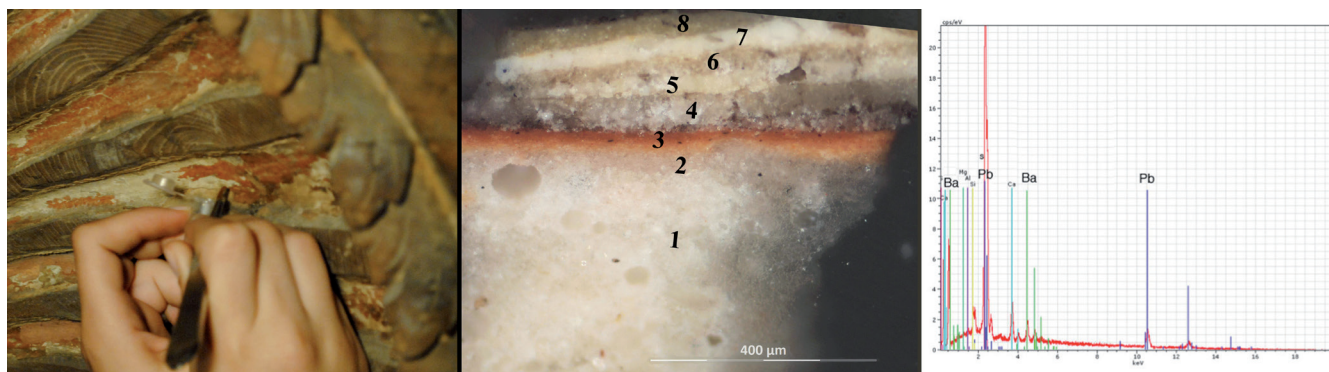
Figure 1.- a) Sample collected in Saint Cajetan's niche; b) Cross-section (scale $400\mu\text{m}$). Original layers: 1 to 3; new ground layers: 4 and 6; new white paint layers: 5 and 7; c) EDS spectrum of layer number 7: identification of Pb and Ba. Photograph, image acquisition and graphic by Patrícia Monteiro.

Only the barium sulphate and lead white lead layers, in the central niche and Saint Cajetan's niche, can be chronologically placed after the 19th century.

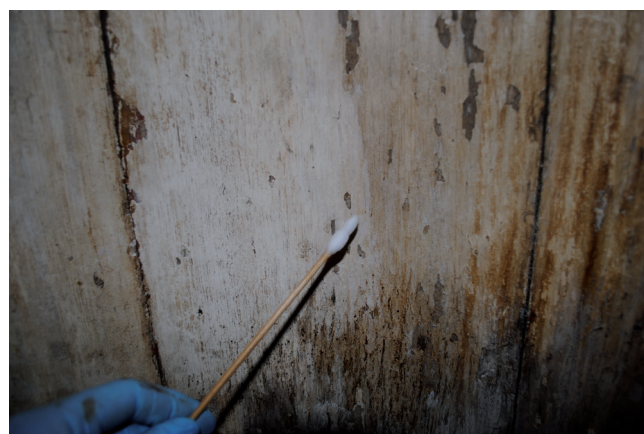
Figure 5.- Removal of the acrylic resin using both saturated and aromatic hydrocarbon solvents. Photographed by Patricia Monteiro.

To remove the inappropriate chromatic reintegration and the acrylic resin deposits, from previous interventions [Image 5], various solvents were used, such as Shellsol® A, Shellsol® D40, 96% ethanol.

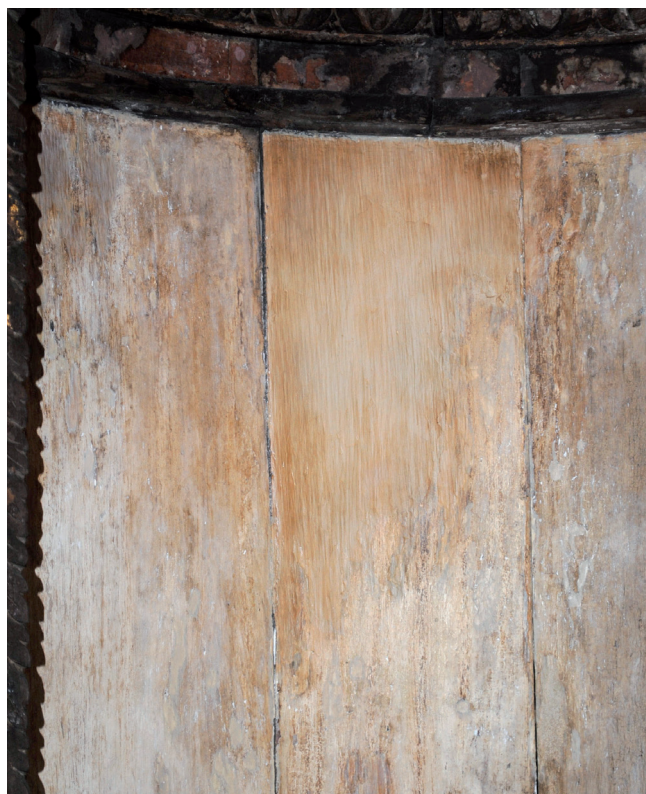
Figure 6.- Central niche during chromatic integration with acrylic paint of the filling paste. Photographed by Patrícia Monteiro.

Following these procedures, it was necessary to integrate the filling pastes according to the enveloping chromatic tonalities [Image 6]. These aesthetic interventions intended to reduce the visual disturbance caused by lacunae in the white areas and the antependium's front, as well as to conceal the filling materials applied on the wooden support. It was a conscience choice to preserve all polychrome layers, as they testify the alterations undertaken through the years.

The filling materials on the white areas' lacunae were concealed using both the *trattegio* and the chromatic selection. The combination of both techniques consists in the application of vertical lines - overlapped and juxtaposed - over a base ton (Bailão, 2011: 55). The pigments (Sennelier® and Kremer®) were agglutinated in an acrylic medium (Liquitex® Glazing Medium), and mixed directly on the palette. Through these two techniques combined, it was possible to achieve a chromatic vibration, colour depth, and saturation similar to the original, but still distinguish the intervened areas [Image 6].

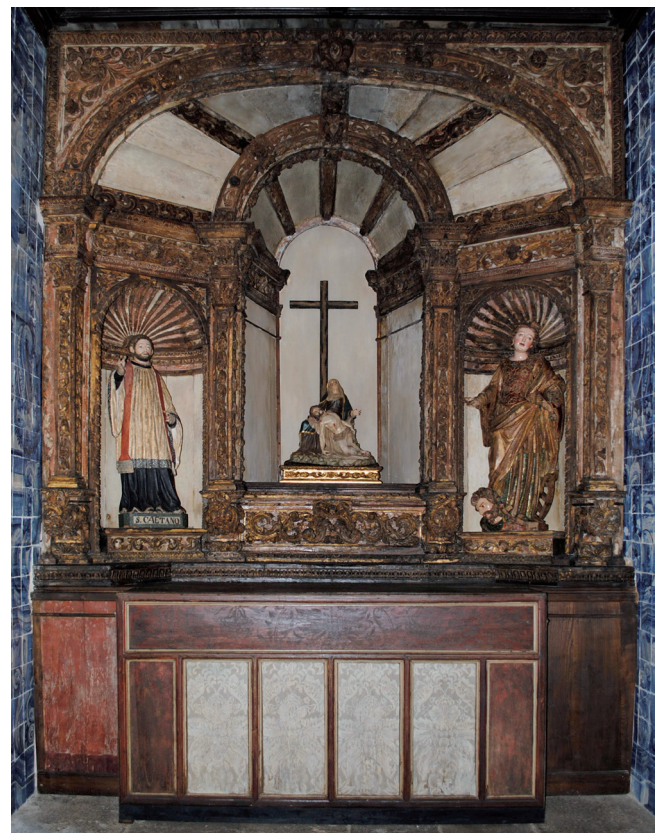
Figure 7.- The retable of Our Lady of Mercy after the conservation treatment. Photographed by Patrícia Monteiro

Finally, the surface sheen was corrected by applying a new layer of the previously mentioned protection coat composed of acrylic resin dissolved in a saturated hydrocarbon solvent (5% Paraloid® B72 in Shellsol® A) [Image 7].
