# Documentation of the current state of the southern elevation of the temple of Our Lady of Candelaria: application of photogrammetry as an auxiliary technique for data acquisition

Isaías Edén Vizcaíno-Hernández, Miguel Angel Soto-Zamora, Alejandro Acosta-Collazo, Rubén Alfonso López-Doncel

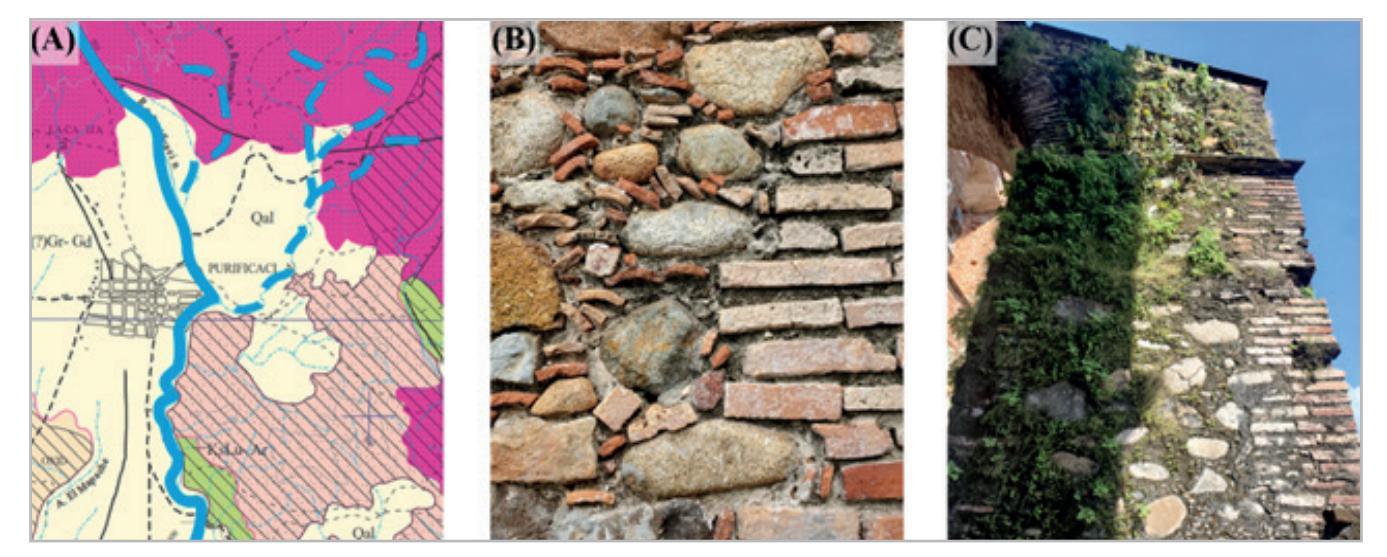
Figure 7.- (A) Pluvial causes. (B) Rounded-edged stones on the second buttress in front of the gate. (C) First buttress behind the tower, damage mainly to bricks and mortar.

temple walls mostly have low absorption (less than 6%) and porosity (between 1.6% and 15.4%). In contrast, the bricks have an absorption of more than 23.7% and a porosity of more than 38.9%. Following the assertions of other authors who establish a relationship between the durability of a material and its porosity (Raheem 2019: 143), it can be estimated that materials such as bricks and mortar will have a lower durability compared to the igneous rocks that make up this historical structure, being more affected by deterioration [Figure 7:C].

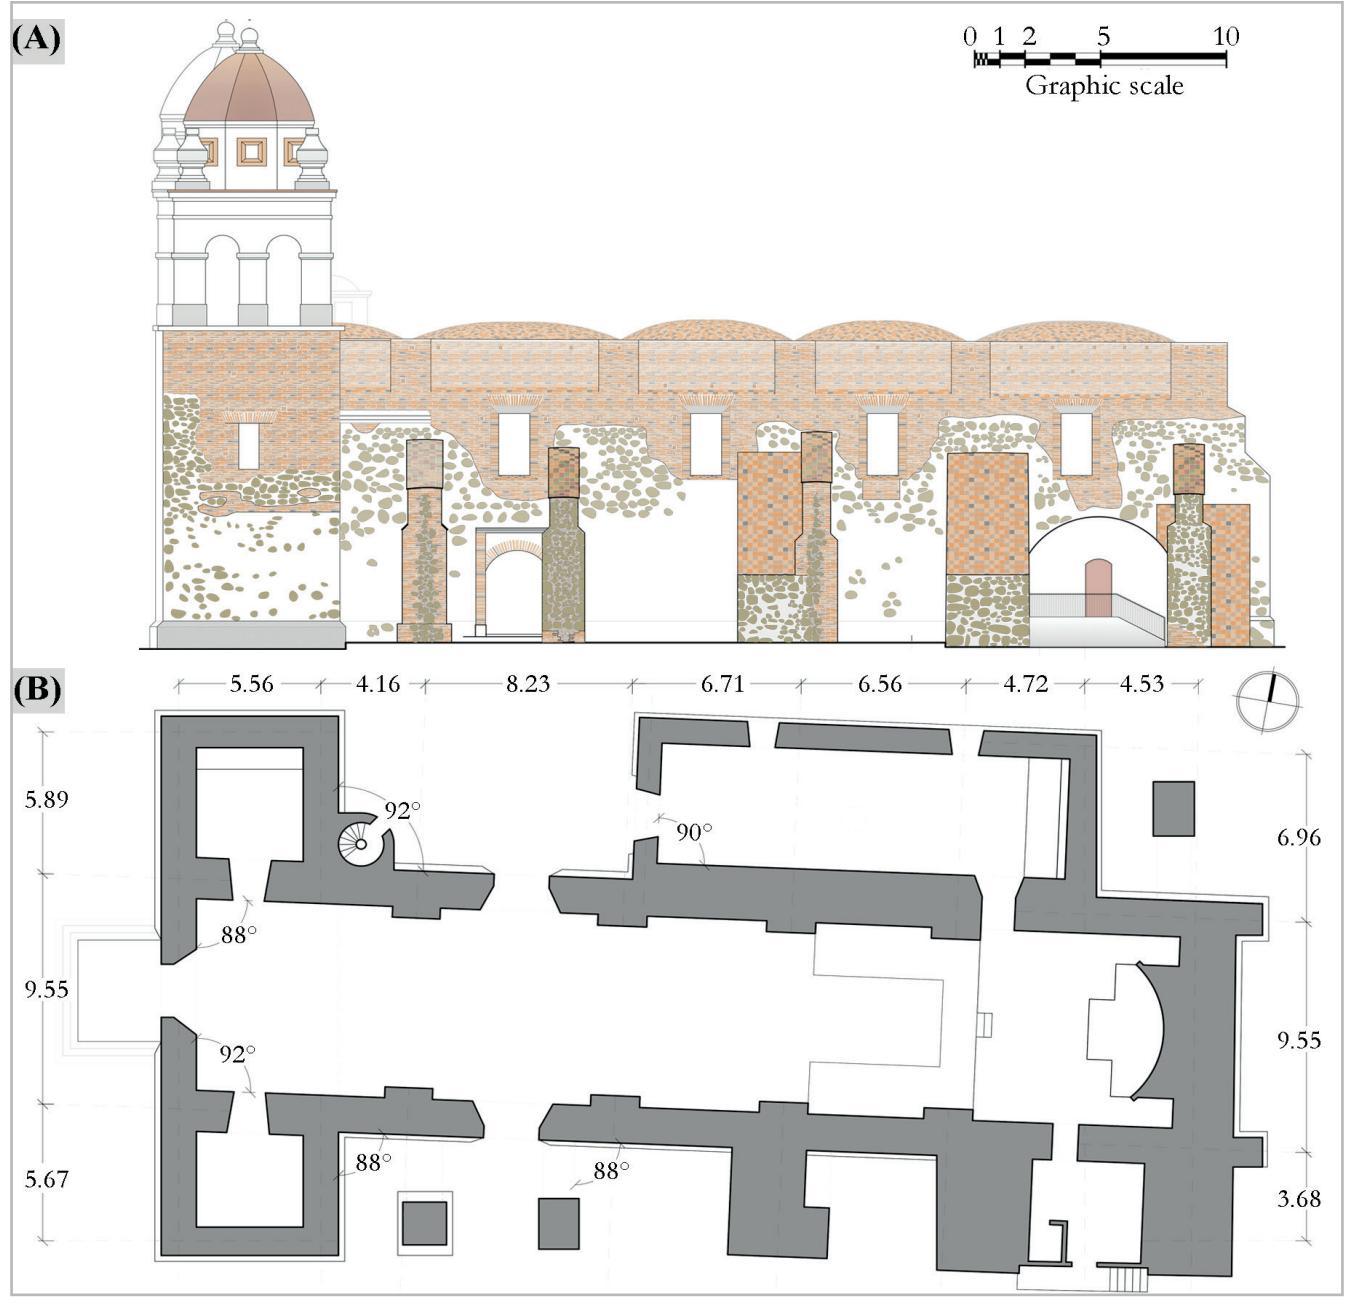
Figure 8.- Architectural representation: (A) elevation view and (B) ground floor.

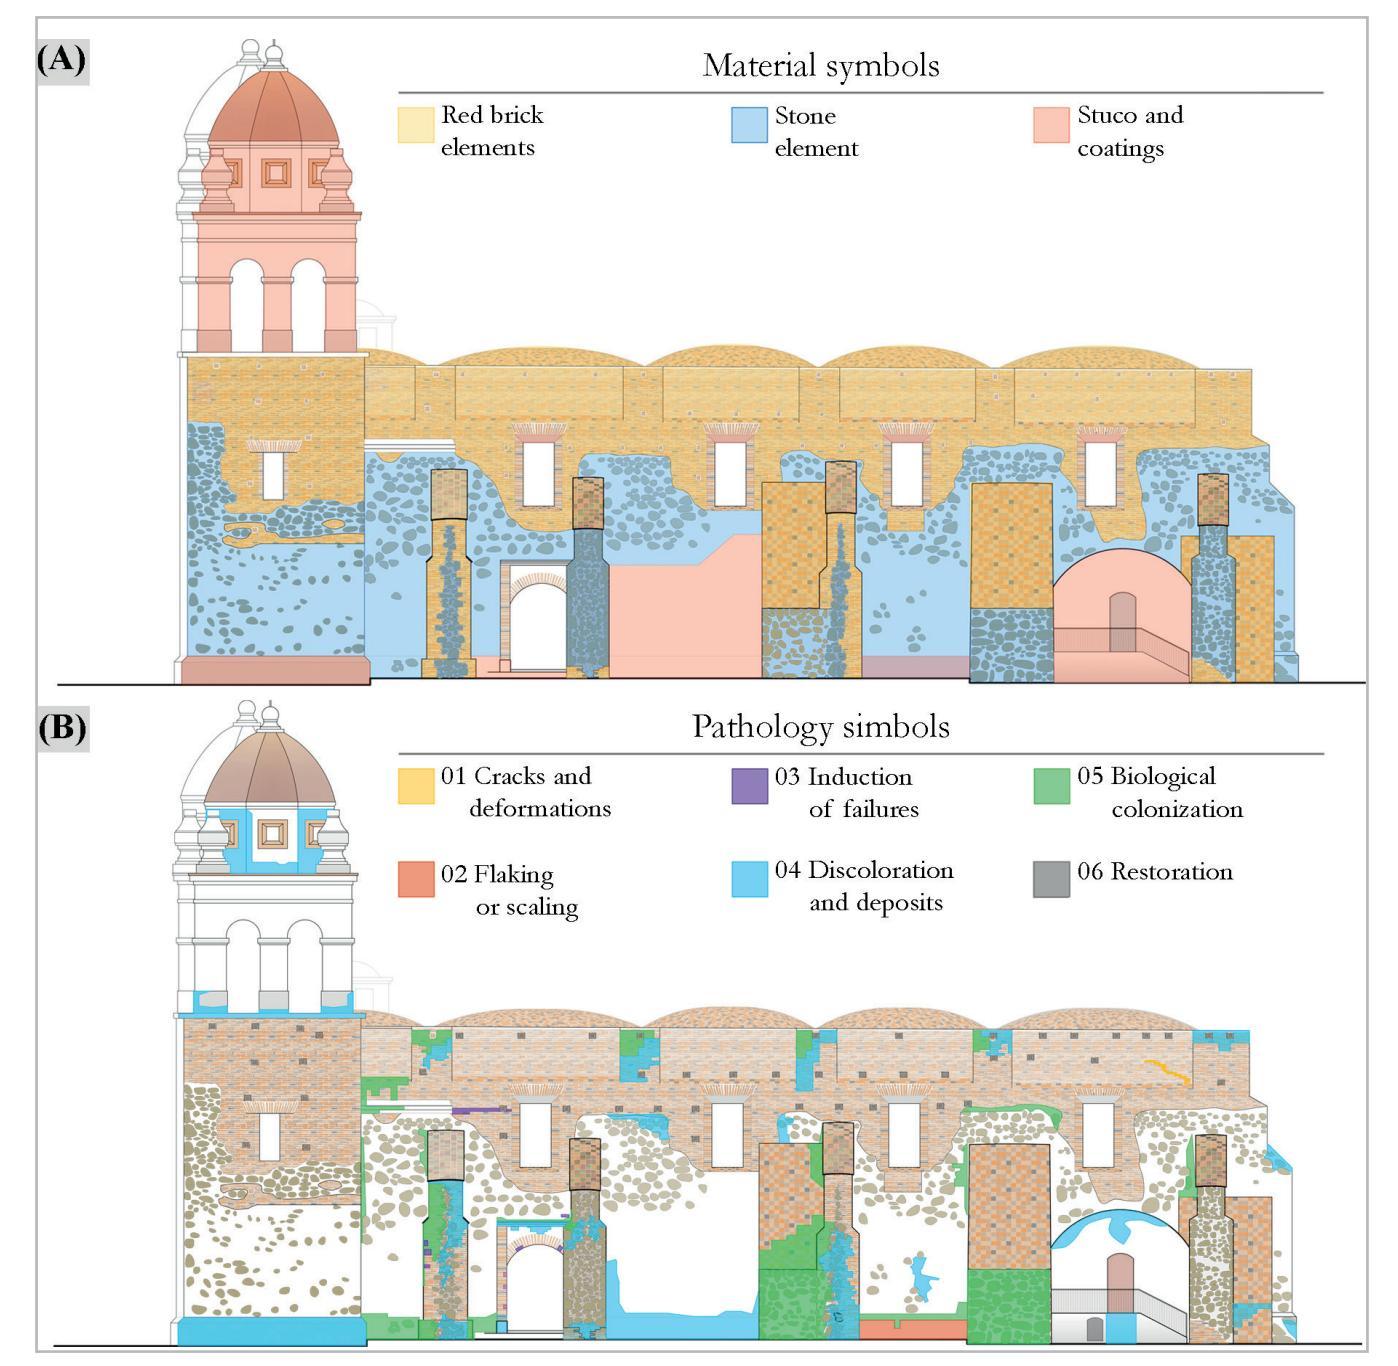
The demarcation of the materials shows that the walls are constructed mainly with stone masonry up to the level of the windows, where a material change is generally seen in the diagonals, giving way to the continuity of the walls with fired red brick masonry that extends from the windows to the roofs. Brick is also found enclosing some buttresses. In addition, square brick tiles are present on the roofs, both on the roofs and on the buttresses. Finally, remnants of plaster or render are observed in the middle of the nave and at the base of the tower, while new plaster is seen in the sacristy and the bell tower [Figure 9:A].

Regarding the mapping of deterioration on the temple, the surfaces with biological colonizations, discolorations and deposits are the most obvious. These colonizations may be responsible for the superficial erosion caused by their roots or the appearance of discolorations and deposits due to the decomposition of organisms (Casas 2018:

Figure 9.- Mappings on the architectural elevation: (A) Materials and (B) Deterioration

58). Although the constant sunlight on the south facade should be unfavorable for these biological colonisations, the invasive species have managed to settle in the porous materials of the temple, mainly in areas that experience periods of sun and shade. These conditions are found between the tower and one of the buttresses, and on the tile-covered buttresses that are in the shade of the trees. Finally, there are small areas of material loss, mainly bricks, and a crack in the upper right corner [Figure 9:B].
