Unveiling the mural painting art of Almada Negreiros at the Maritime Stations of Alcântara (Lisbon): diagnosis research of paint layers as a guide for its future conservation

Milene Gil, Mafalda Costa, Mila Cvetkovic, Carlo Bottaini, Ana Cardoso, Ana Manhita, Cristina Dias, António Candeias

Abstract: This paper reports the diagnostic research of deteriorated paint layers from three mural panels made by Almada Negreiros found in the Alcântara Maritime Station in Lisbon. The aim was to understand the main decay phenomena to aid future conservation works. The methodology comprised in-situ analyses by technical photography in Vis, Vis-RaK and UVF, p-OM and h-EDXRF; micro sampling; OM, SEM-EDS, μ -XRD, μ -Raman, μ -FT-IR and Py-GC/MS. Preliminary results show that all the paint layers analyzed are affected by salts (alkali sulphates) that over time have caused flaking, lack of cohesion, erosion, and lacunae. The light greenish/greenish bluish paint layers in all three panels are the most affected. No organic binders were identified, only the presence of vinyl polymer in glossy paint surfaces.

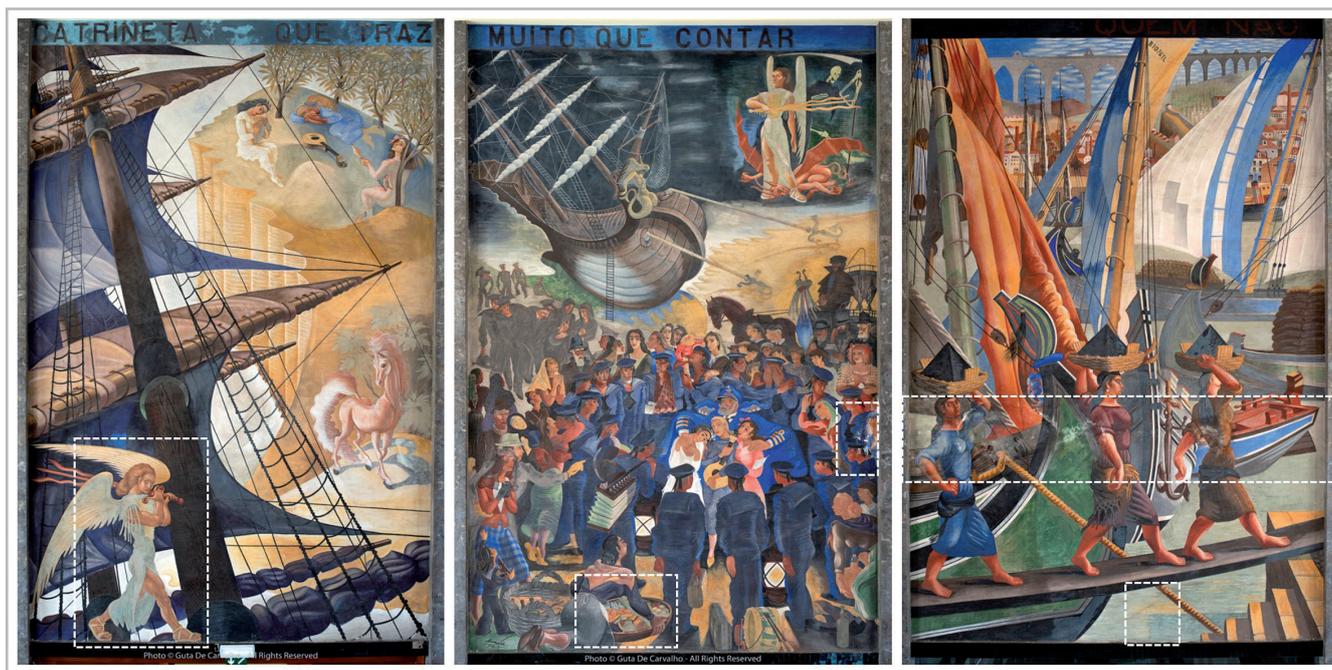
Figure 1.- Murals P2, P3 and P6 with the location of the deteriorated paint layers analyzed in 2020 (white squares) (photos by Guta Carvalho 2020 © all rights reserved).

The diagnostic research undertaken focuses on a collection of three murals painted between 1943 and 1945 at the main hall of Alcântara Maritime Station. In total, eight mural panels with 7.20 x 3.80 meters are presented on the east and west walls: two triptychs and two individual paintings. This research is constrained to the mural panels, referred to as P2, P3 and P6, that depict scenes of everyday life and the mythological history of *nau catrineta* [Figure 1].

The main deterioration features noticed in the three mural panels by visible and raking light were flaking lack of cohesion, erosion, and lacunae of paint layers. Particularly affected by severe flaking is a light greenish/greenish blue paint layer identified in the Angel's garment of P2 and in the other two panels in the background and in some decorative motifs [Figure 1 to Figure 3].

In terms of deterioration, P6 presents the most complex case due to the extent and degree of the paint layers affected [Figure 1]. The main decay phenomena in this panel follows the pattern of the two previous ones: salts induced stress and subsequent flaking, lack of cohesion, erosion and lacunae of paint layers as shown in Figure 3 in Vis e Vis-Rak.

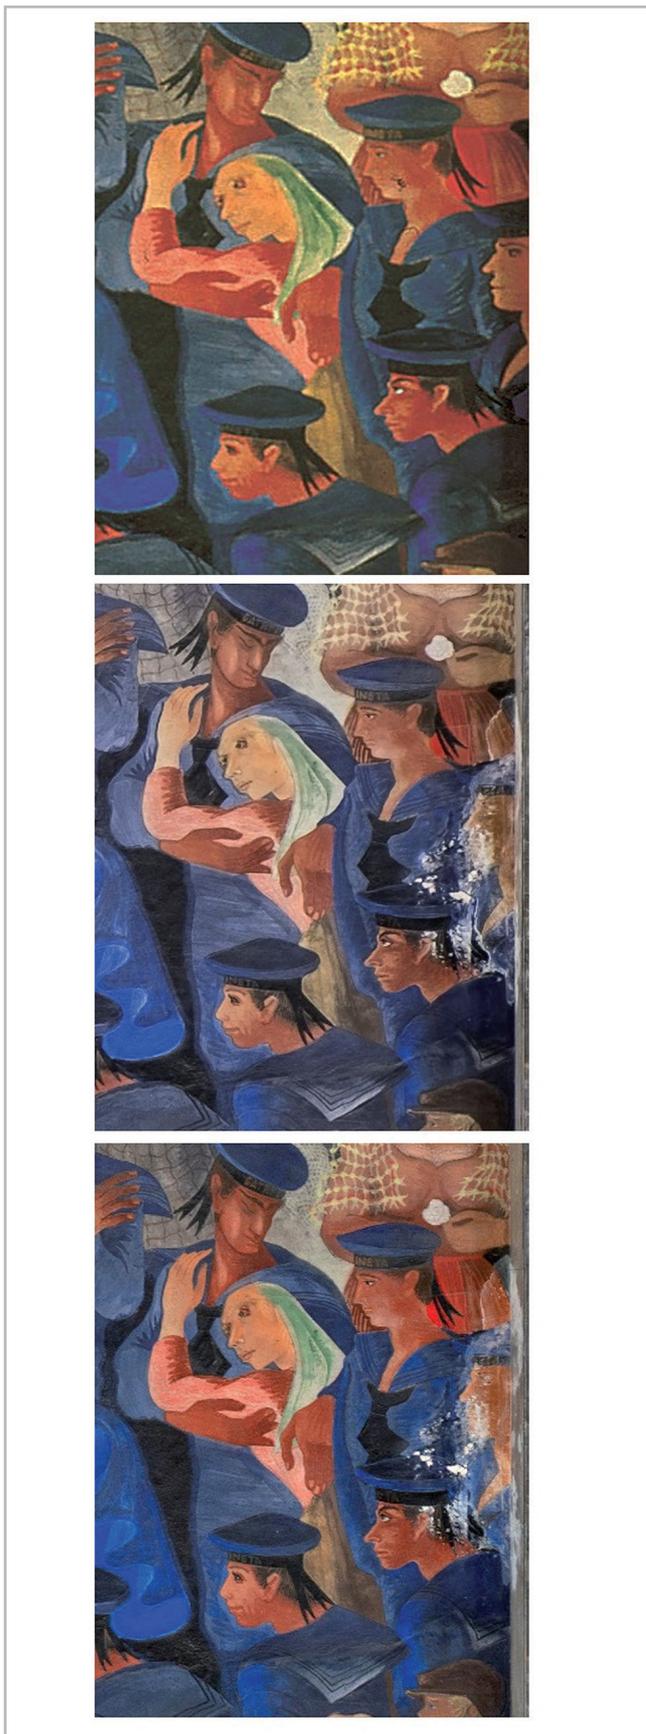
Figure 2.- Three images of a detail of P3. From top to bottom, APL Archival (late 1990s), CML-José Vicente (July 2013), Guta Carvalho (June 2020). Salt veils and efflorescence's are visible on the right border of the panel (photo credits © all rights reserved).

Salt veils, salt concretions and salt efflorescence are clearly seen with the naked eye in P3 and P6 [Figure 2 and Figure 3]. The decay that the salts have induced over the past twenty years in P3 is shown in Figure 2. From detailed observation of the three sets of photographs from the late 1990s, 2013 and 2020 it is possible to conclude that this phenomenon is still ongoing. The occurrence of salts could have been trigger by water infiltration and condensation due to old and damaged installations and leaking pipes (Hanafi *et al.* 2018; Young 2008). It must be noted that within the main hall, the mural panels span over two stories high, which positions the floor joint in the middle of the paintings as illustrated in Figure 4. The most deteriorated areas of the mural panels are aligned with this junction favoring the occurrence of thermal bridges (Jedidi & Benjeddou 2018; Zedan *et al.* 2016). A thermal bridge can be explained as the movement of heat across an object that is more conductive than the surrounding materials leading to heat loss. Thermal bridges in buildings, besides having an impact on thermal resistance, can cause water condensation within the architectural elements. This may be one of the reasons for the current state of conservation of the paint layers in panels P3 and P6.

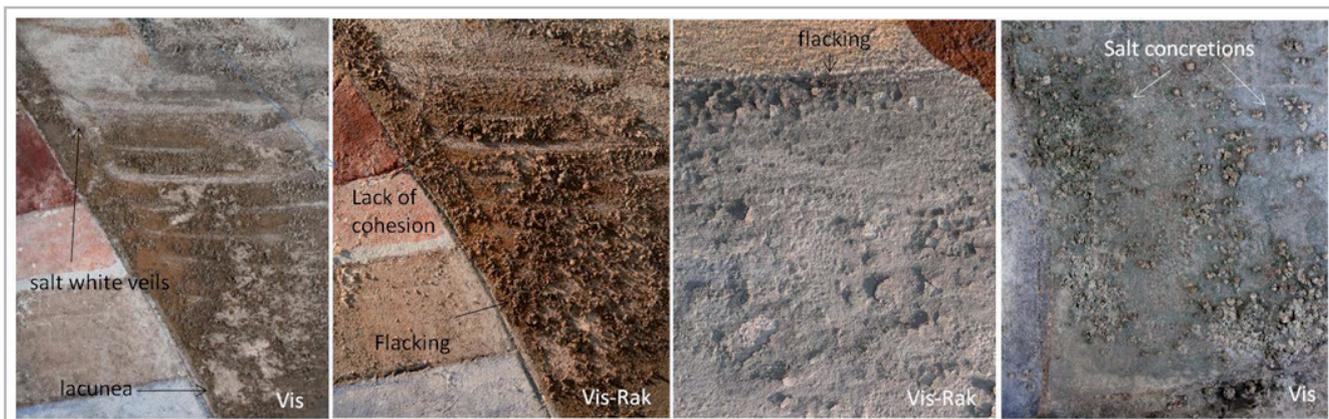
Figure 3.-Details in Vis and Vis-Rak of deterioration features in P6: flaking, lack of cohesion, lacunae, salt veils, concretions, and efflorescence.

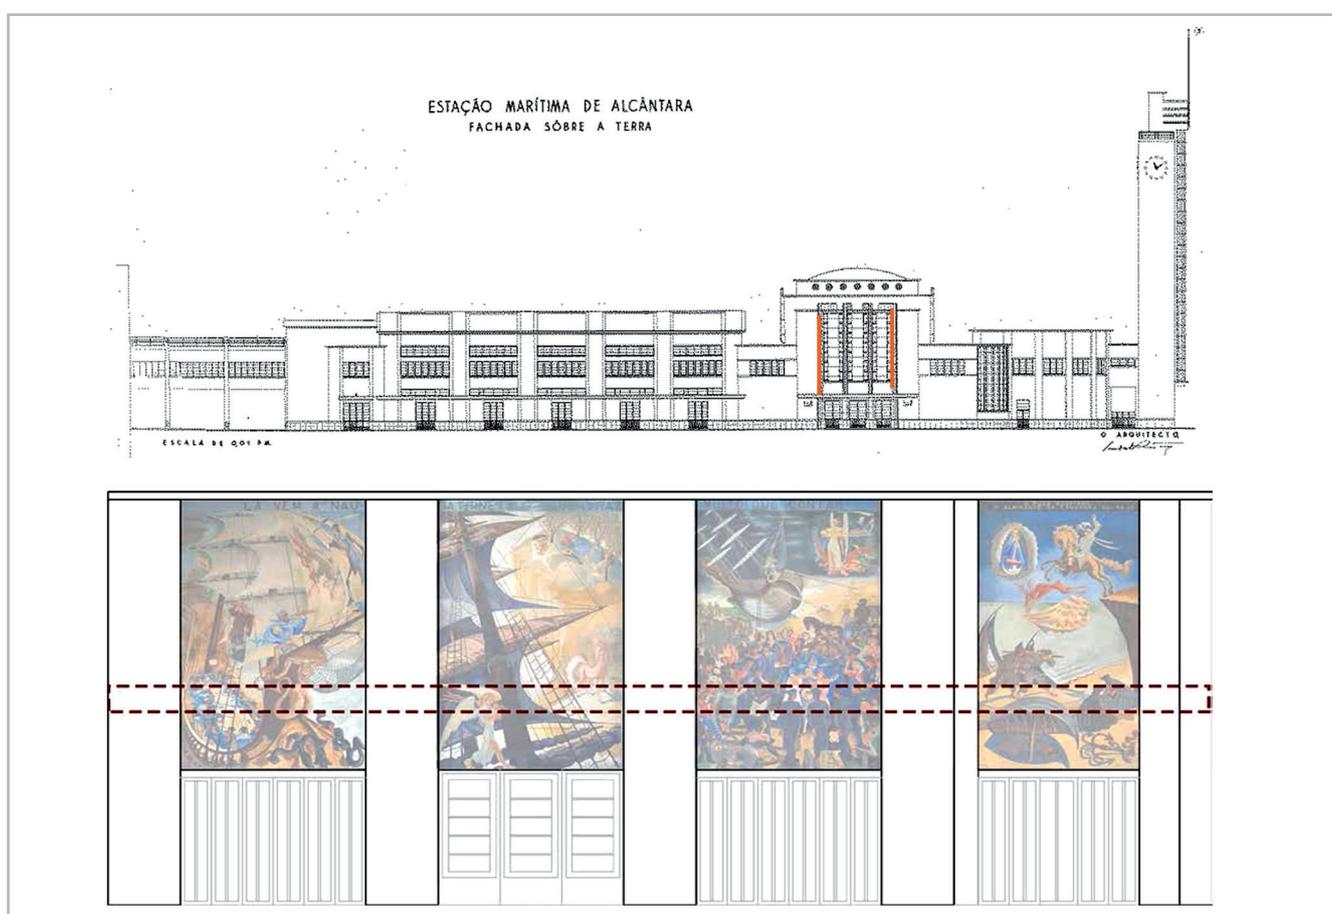
Figure 4.- On top, cross section of Alcântara station with marked positions of the murals. Source of the section (Monteiro 2012); on the bottom, scheme of the west wall with the display of the murals and indicated position of thermal bridge that corresponds with construction joint between two floors. Drawing by Mila Cvetković 2020.

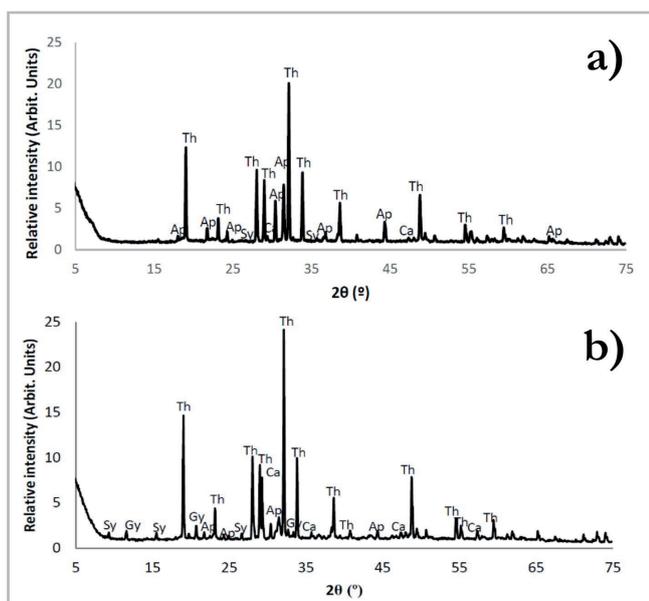
Figure 5.- XRD diffractograms of samples P3B_5 a) and P3B_6 b) showing identified mineralogical phases (Ca – Calcite, Th – Thenardite, Sy – Syngenite, Ap – Aphthitalite, Gy – Gypsum).

Five powdered samples of salt efflorescence collected from P3 and P6 were analyzed by μ -XRD, for mineralogical phase identification [Table 1, Figure 5]. The results obtained revealed that sulphates were the main phases found in all five samples: thenardite (Na_2SO_4), gypsum ($\text{CaSO}_4 \cdot 2\text{H}_2\text{O}$), syngenite ($\text{K}_2\text{Ca}(\text{SO}_4)_2 \cdot \text{H}_2\text{O}$), apthitalite ($\text{K}_3\text{Na}(\text{SO}_4)_2$)

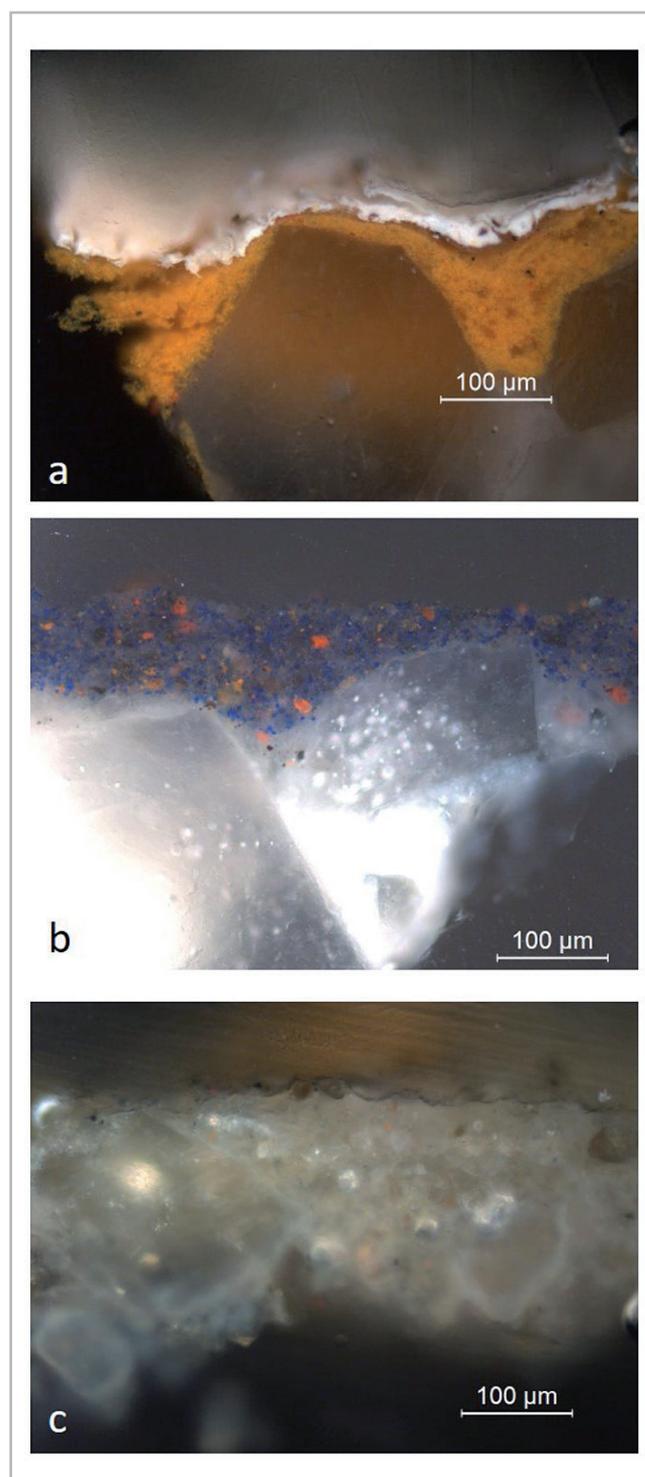
Figure 6.- OM-Vis of paint layers cross sections P6C_2(a), P3B_2(b) and P6C_5 at 200x magnification.

These findings are rare because in the past the use of Cd pigments in mural paintings, especially with fresco technique, was controversial. The stability of the pigments relied on their chemical composition and manufacture process. According to Feller (1986), cadmium yellow light hues were not advised since they could contain cadmium oxalate or carbonate, or even free sulfur, which would trigger reactions in the alkaline medium leading to a fast fading of the color. Maybe this can be the reason why Almada Negreiros limited the use of these pigments in these murals, but further research is needed to reach firm conclusions. However, it is important to note that in the two Cd-containing paint layers analyzed by OM there is no evidence of pigment discoloration [Figure 6a]

light as granules of uniform rounded shape and of size $\leq 4 \mu\text{m}$ [Table 2, Figure 6b].

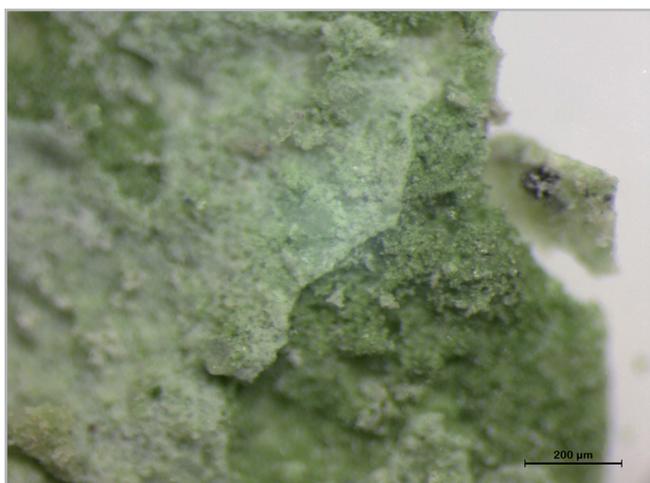
Figure 7.- OM-Vis of sample P6A_16 at 100x magnification.

The identity of the chromophore remains unclear for samples P6A_14 and P6A_16 [Figure 7] collected from the bright and darker greens paint layers of the fishing boat in P6 [Figure 1]. Elemental analysis revealed an enrichment in Fe, Al, K, Cu, As, Sr, Mg, Si, Ca, Na, and Cl, which could indicate different kinds of pigments combined with salts. Micro-FT-IR on P6A_14 and P6A_16 suggests the presence of emerald green pigment, a copper(II) acetoarsenite of formula $\text{Cu}(\text{CH}_3\text{COO})_2 \cdot 3\text{Cu}(\text{AsO}_2)_2$ based on the characteristic bands at 1556 and 1455cm^{-1} (Cortea *et al.* 2020; Fiedler&Bayeard 1997), but this assignment is still uncertain due to the absence of As in h-EDXRF [Table 2]. On the other hand, the Raman spectra of both green micro-samples reveal the following bands at 154, 196, 221, 314, 353, 381, 449, 472, 497, 537, 618, 636, 670, 754, 883, 1025, 1077, 1150, 1225, 1303, 1353, 1447, 1471, 1513, 1552 and 1590cm^{-1} , which could be tentatively assigned as the synthetic organic pigment PG 8 (Coccatto *et al.* 2016).

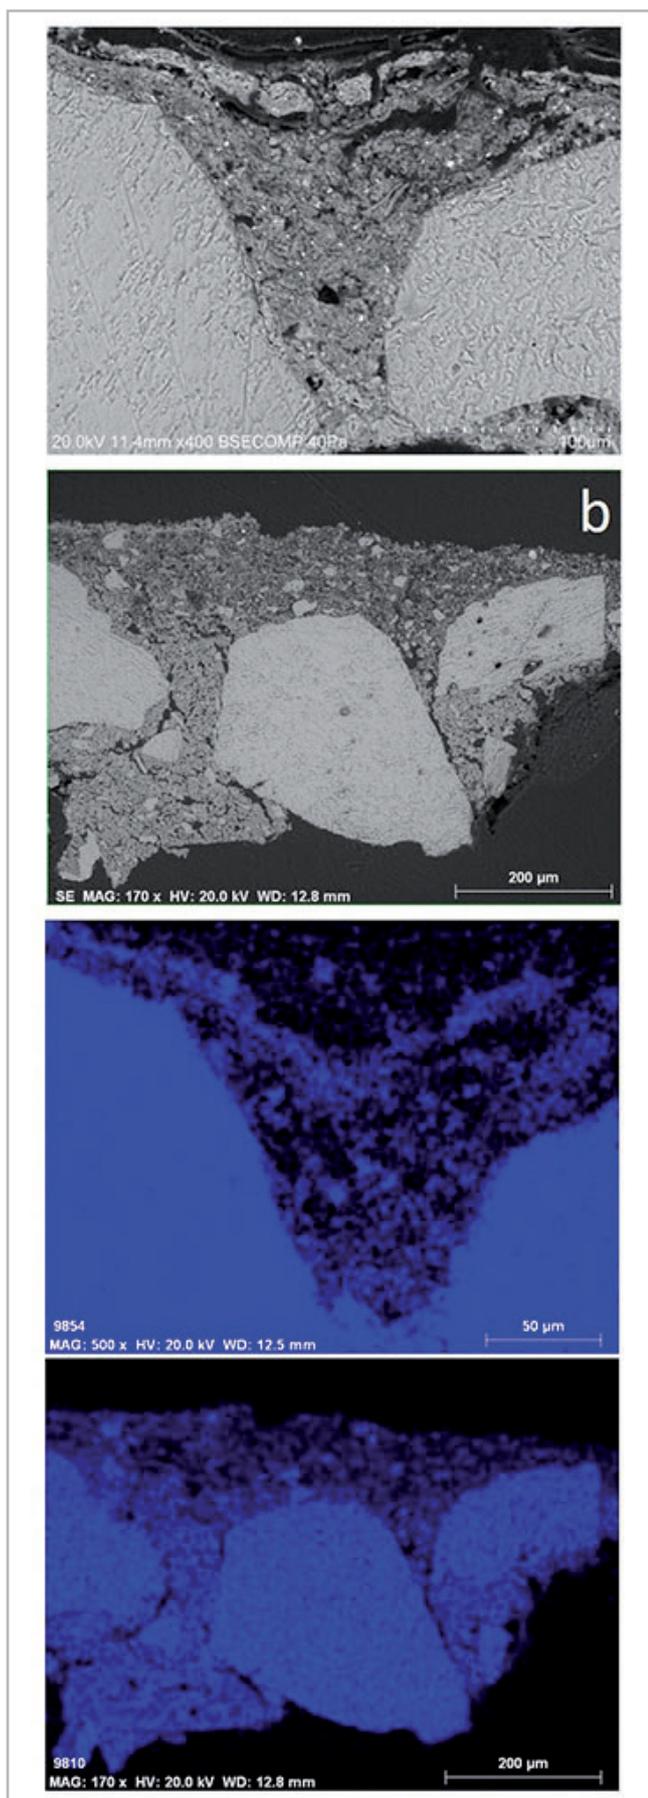
Figure 8.- SEM BSE images paint layers cross sections P6C_2(a), P3B_2(b) and corresponding EDS Ca elemental map distribution (in blue).

down the colors. Stratigraphically this technical feature can be ascertained by SEM-EDS in the interface mortar-paint layer by the absence versus the presence of a Ca-crust layer of carbonation. Its presence would suggest that the mortar surface was already dried when the painter started to paint. This was not the case of the paint layers analyzed. The absence of a Ca-rich crust is confirmed in the interface mortar-paint layer in SEM-EDS BSE images as seen in Fig.8. Furthermore, in most paint layers analyzed the pigment particles are embedded in a Ca matrix that can range up to $104\ \mu\text{m}$ thickness – a strong indication that the pigments were not mixed only with water (as in the case of buon fresco) but with a thicker solution of calcium hydroxide (e.g., lime milk) before being laid down on the fresh mortar (lime fresco technique).
