Heritage value of building materials: Former Workers Hospital of Maudes, Madrid (Spain) case study

Elena Mercedes Pérez-Monserrat, Rafael Fort, María José Varas-Muriel, Mónica Álvarez de Buergo

Key words: documental resources, analytical techniques, heritage conservation, limestone, decorative ceramics, artificial stone.

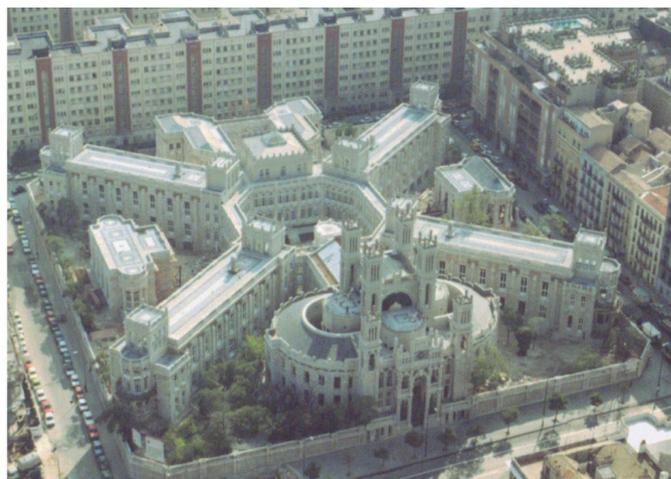
Figure 1.- Galician architect Antonio Palacios Ramilo (1874-1945) and the Former Workers Hospital of Maudes (Madrid, Spain). Images yielded by the Specialized Documents Centre of Madrid Environmental Regional Department.

as a benefic institution to provide free medical care to the working class people without economical resources (Ciudad and Carrillo 2001: 13, 20). Taking advantage the healthsome breeze of the area, Palacios designed a building comprised by four wings arranged diagonally around several courtyards. The architect conferred to the property a strong hygienist and humanitarian character (Crónica e Información 1912: 1). He created a warm atmosphere by means of gardens as well as with the conjunction of lights and shades (Pérez-Rojas 1987: 115). The building was enclosed by a surrounding wall.

The façades and the wall are comprised by stonework (mainly a light-colored limestone) grouted by joint

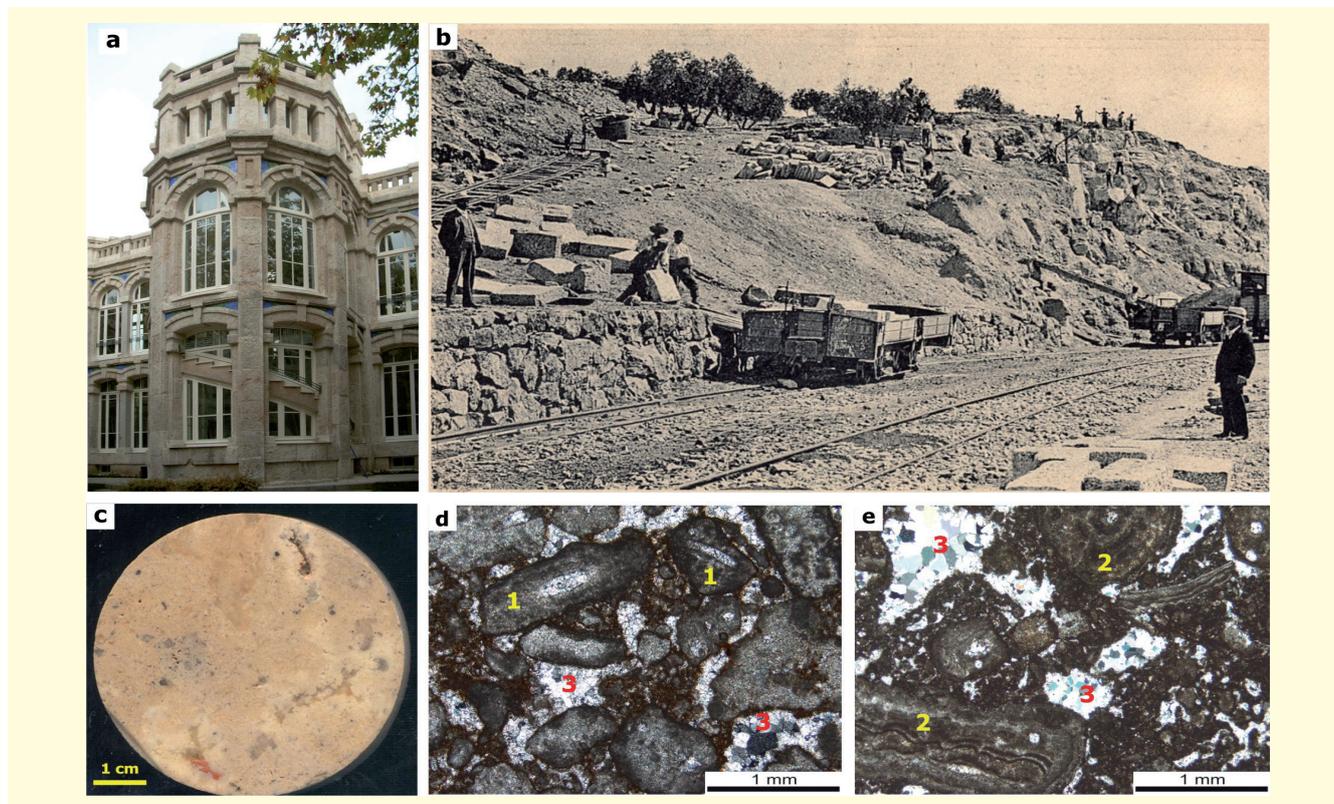
Figure 2.- Natural stone: a light-color limestone. a: façades stonework shape by limestone; b: limestone quarrying on Cornicabra' quarries at the beginning of the XX century (courtesy of the Historic Railway Archive from the Railway Museum Madrid and Spanish Railways Foundation); c: macroscopical features of the limestone used at façades (with light-color and high cementation degree); d: polarised optical micrographs of façade limestone (parallel nicols) and e: from quarry limestone (crossed nicols) -cemented characea algae (1), stromatolitic structures around characea algae sections (2) and interparticle porosity cemented and/or recrystallized (3).

The macroscopic and petrographic (by means of POM technique) comparison of the limestone extracted from the façades and the stone samples taken from the historical quarry working front was performed. The most frequently limestone used at the façades and surrounding wall is a compact and light-colored limestone that corresponds to the homogeneous (micritic limestone) and stromatolitic-oncolytic (biosparite) -with many molds of bioclasts such as characea algae, gastropods and stromatolitic structures- facies of the lacustrine carbonates from the Miocene Upper Unit of the Tertiary continental basin of the Southeast of the region (Perez-Monserrat et al 2011: 298, 301). The significant recrystallization and cementation features, typical of these carbonates (Calvo et al 1989: 285, 295; Alonso-Zarza 1992: 24, 27), reduce the primary porosity and provide a high compactness to the rock. Therefore, these carbonates entail a building material especially appropriated to withstand compression stresses and to resist water action and ageing. [figure 2]

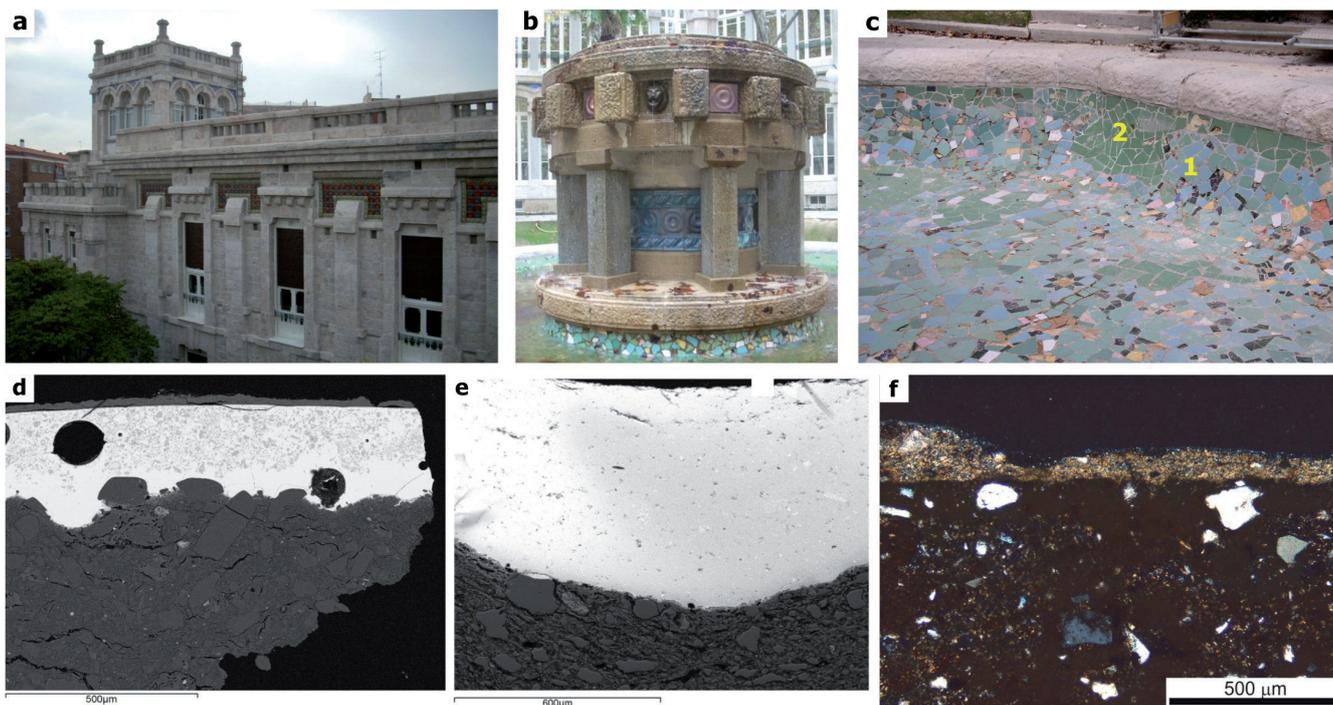
Figure 3.- Decorative ceramics: ceramic panels and tile *trencadix*. a: upper part of façades decorated with ceramic panels; b: original raindrop tiles on the body of the central fountain; c: basin of the fountain adorned with tile *trencadix* -original tiles (1) and tiles placed at 80s (2)-; d: original tiles manufactured by Zuloaga and e: tiles elaborated at 80s (both SEM-BSE mode images) -differences on texture and on ceramic body/glazes contact were observed-; f: polarised optical micrograph of the original tile *trencadix* (crossed nicols), quartz inclusions in ceramic body and the glaze applied on the ceramic body were observed.

By means of POM, XRD, SEM-EDS and UV-Vis techniques, Perez-Monserrat et al (2013: 489-490; 2016: 61-62) provided new data on the manufacture of these ceramic materials. Therefore, Zuloaga's pieces contain grog and quartz inclusions of very heterogeneous shape and size. A lead glaze (with circa 60 wt% Pb) was applied. Titanium and zirconium oxides were added and the bluish tone could be achieved by means of using the Zr-V blue pigment; the uneven textural features observed by POM and SEM mainly respond to their manual processing. In the replaced panels, ceramic bodies contain a high amount of quartz inclusions; the similar size and shape of these inclusions as well as the very even texture of glazes are primarily due to the mechanised manufacturing of the replaced panels. Glazes are also leaded (40 wt% Pb), zinc oxides were added and Cu²⁺ ions provide the turquoise color of the string pieces.

Regarding the *trencadiç* of the basin, the original tiles were made from calcium-rich clays, so the Sevillian company that manufactured the interior decorative ceramics could also process these tiles. The repair ones were deliberately elaborated

to be stronger than the original ones, chiefly by adding more quartz inclusions and firing at higher temperatures. From the mineral paragenesis detected by XRD, it can be inferred that original tiles were fired at temperatures higher than 800 °C and the replaced tiles at temperatures higher than 900 °C. Glazes display a heterogeneous texture with abundant particles, a lead content over 22 wt% was determined; VI-Vis pointed out that the blue color of original pieces is mainly due to the presence of Co²⁺ ions and the green color of the replaced ones is achieved by the existence Co²⁺ and Cr⁶⁺ ions. [figure 3]

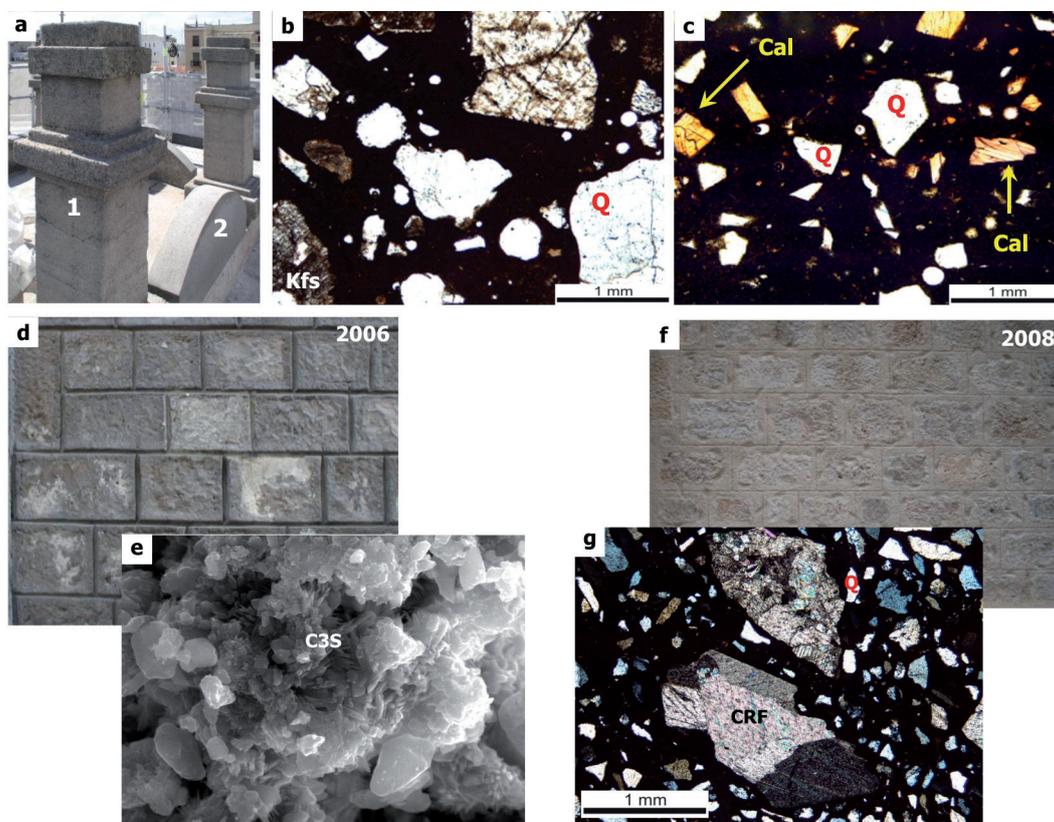
Figure 4.- Artificial stone, coatings and joint mortars. a: top construction elements made by artificial stone -original elements (1) and replaced at 80s-; b: polarised optical micrograph corresponding to original artificial stone and c: to replaced one (both crossed nicols) -quartz (Q), potassium feldspar (Kfs) and calcite (Cal)-; d: joint mortar applied at 60s and e: observed by SEM-SE mode, with alite (C3S) phase mineral presence; f: joint mortar placed in 2006-2008 restoration and g: observed by polarised optical microscopy (crossed nicols) -quartz (Q) and calcitic rock fragment (CRF)-.

Results from POM, XRD and SEM-EDS studies pointed out that the artificial stone, stone imitation coatings and joint mortars studied are mainly composed of silica and/or calcitic aggregates with lime and/or cement as binders. The detection by means of XRD and/or SEM-EDS of belite, alite and/or gehlenite mineral phases revealed if natural or artificial cement (Portland) was used. While belite and gehlenite are normally formed in natural cements, alite mineral phase defines artificial cement (Lea 1976; Callebaut et al. 2001: 400, 402).

Therefore, the original artificial stone is made of natural cement and the one placed during the 80s is made of lime and artificial cement. Related to the limestone imitation coatings, the original ones were made using also natural cement; those elaborated at the 80s are constituted by aggregates obtained from the crushing of limestone and lime binder. Regarding joint mortars, original gypsum mortars within joints have been identified; the thick joint mortar that before the 2006-2008 intervention was at the external face of the surrounding wall (applied by the 60s) was made of silica aggregates and artificial cement binder. The joint mortar placed during the 2006-2008 intervention was composed of calcite aggregates and lime binder. [figure 4]
