## Stone provenance and conservation of the Trinitarias Descalzas of San Ildefonso convent, Madrid (Spain)

David Martín Freire-Lista, Rafael Fort

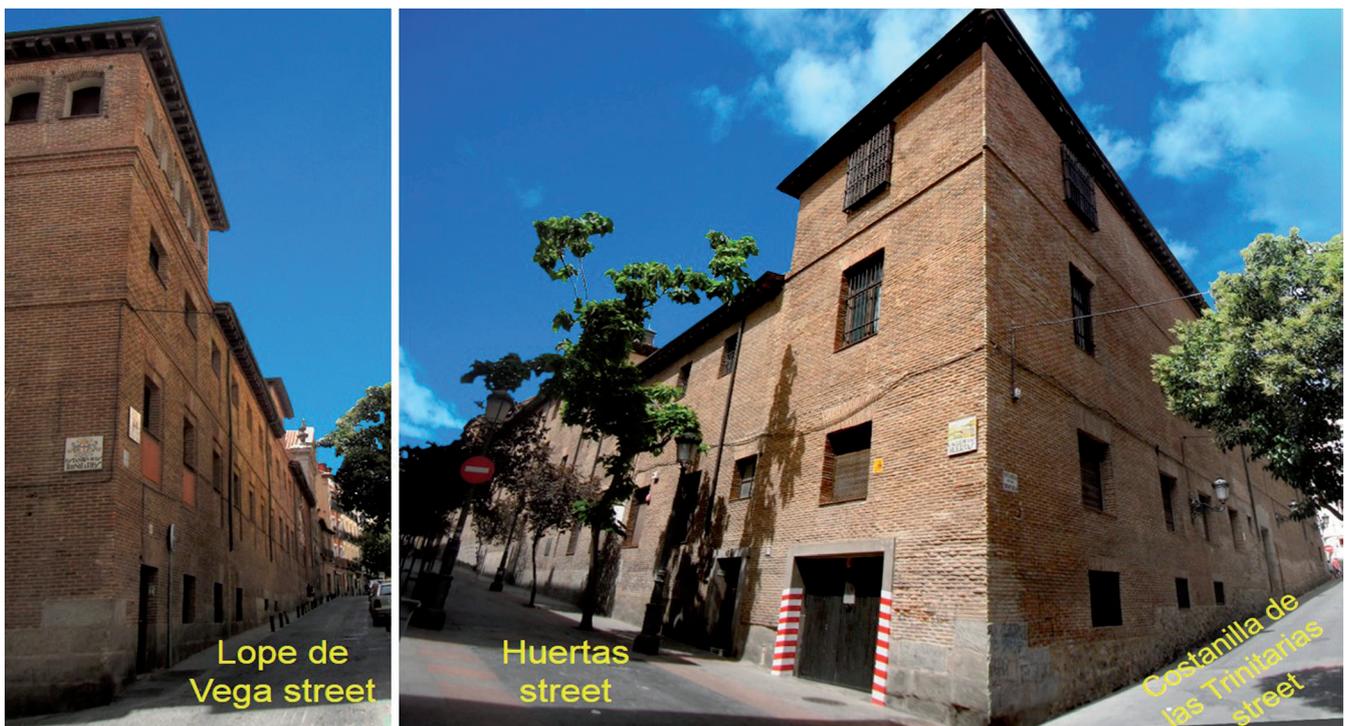
Figure 1.- The three façades of the Convent of Trinitarias Descalzas of San Ildefonso (Madrid).

The stones used in the CTDOSI are those that are traditionally used in Madrid (Fort et al. 2013: 421). These include flint, Alpedrete granite, Cretaceous dolostone and Miocene limestone of the Madrid basin. Some of these stones have been reused from the houses that were previously on this site. Thus, the convent has plinth masonry sections with flint and granite ashlars. Plinth of the Huertas street is composed by granite ashlars. The plinth of Costanilla de las Trinitarias street is composed of masonry flint. There are granite ashlars and rough flint stones in the plinth of Lope de Vega street [Figure 1].

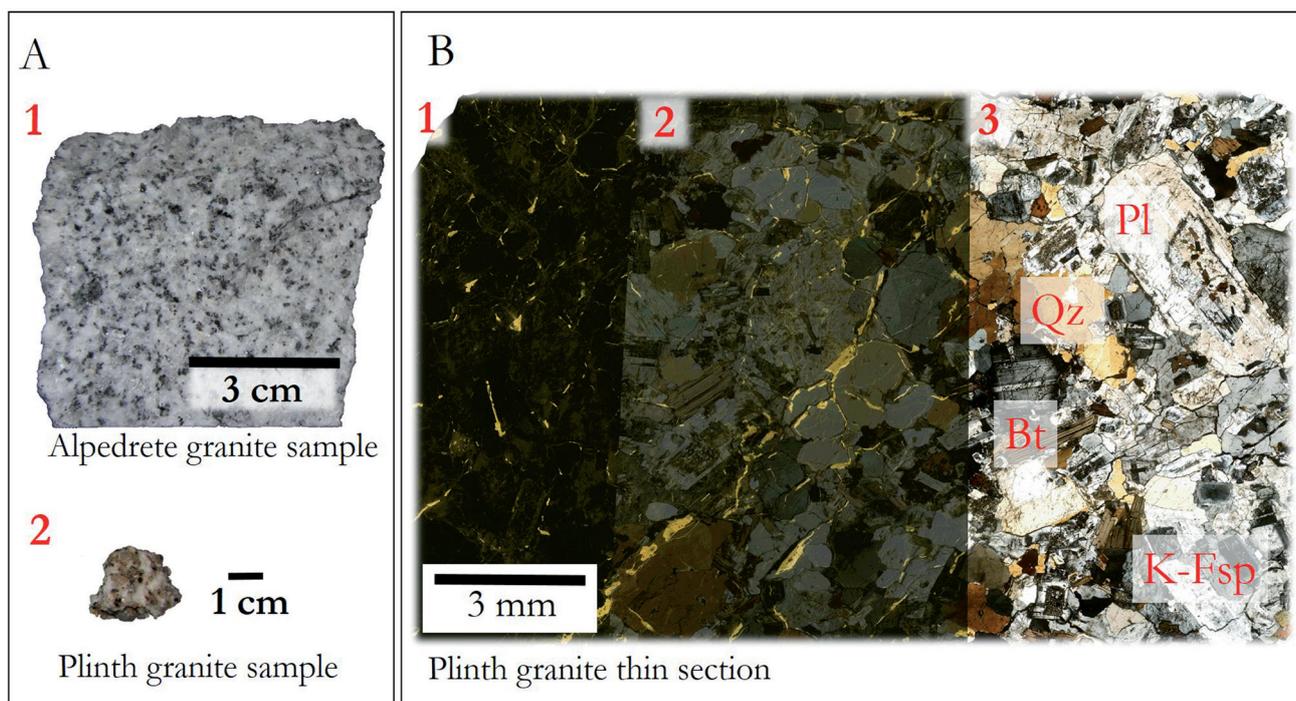
**Figure 2.-** A: Granite samples. A1. Fresh granite sample from an Alpedrete quarry. A2. Plinth granite sample. B thin section removed along a granite ashlar sample from CTDOSI plinth. B1: Fluorescence light micrograph mosaic, showing microcracks. B2: Fluorescence micrograph mosaic overlaid on polarized micrograph mosaic showing microcracks and mineralogy; B3: crossed nicols mosaic; Biotite (Bt), quartz (Qz), plagioclase (Pl), Potassium feldspar (K-Fsp).

The original granite ashlar have very similar characteristics and therefore correspond to the same extraction area. Granite is a hypidiomorphic monzogranite, equigranular of fine to medium crystal size, petrography identical to Alpedrete granite, which has been nominated as a 'Global Heritage Stone Resource' due to its significance in the built heritage of Madrid. (Cooper et al. 2013, Freire-Lista et al. 2015 c, d). The analyzed thin section has mainly intercrystalline and transcrystalline microcracks (Figure 3B). The granite linear microcracks density is 0.7.

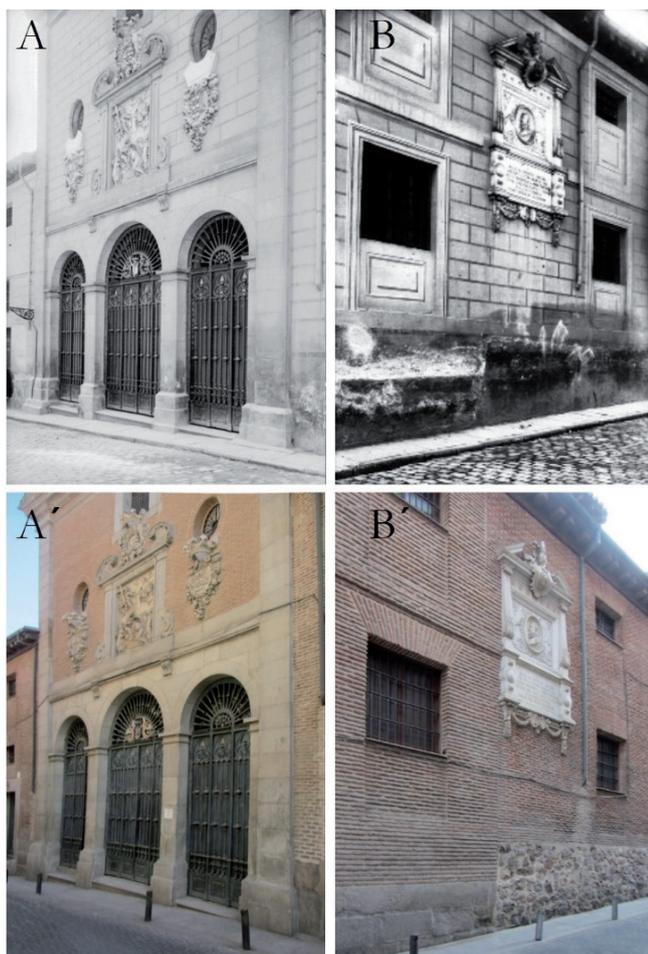
**Figure 3.**- Top: Photography by the 1930s (Before the Spanish Civil War of 1936-39). Bottom: Current photographs (2016).

All CTDOSI façades were coated with lime plaster in 1889, and the plinth was plastered in 1899. This plaster was removed after the Spanish Civil War, leaving the brick and stone faces exposed as currently preserved [Figure 3].

The dolostone coat of arms shows loss of cohesion and soiling. The limestone of the lateral crowns is, along with the flint, the best preserved stone because lateral limestone crowns have been installed in the CTDOSI more recently [Figure 3A and A'].].

The Carrara marble is generally in good condition, its black patina has been eliminated in the subsequent restoration after the Spanish Civil War [Figure 3B and 3B']. Its surface has slight dissolution and increased surface area, which increases vulnerability to decay.

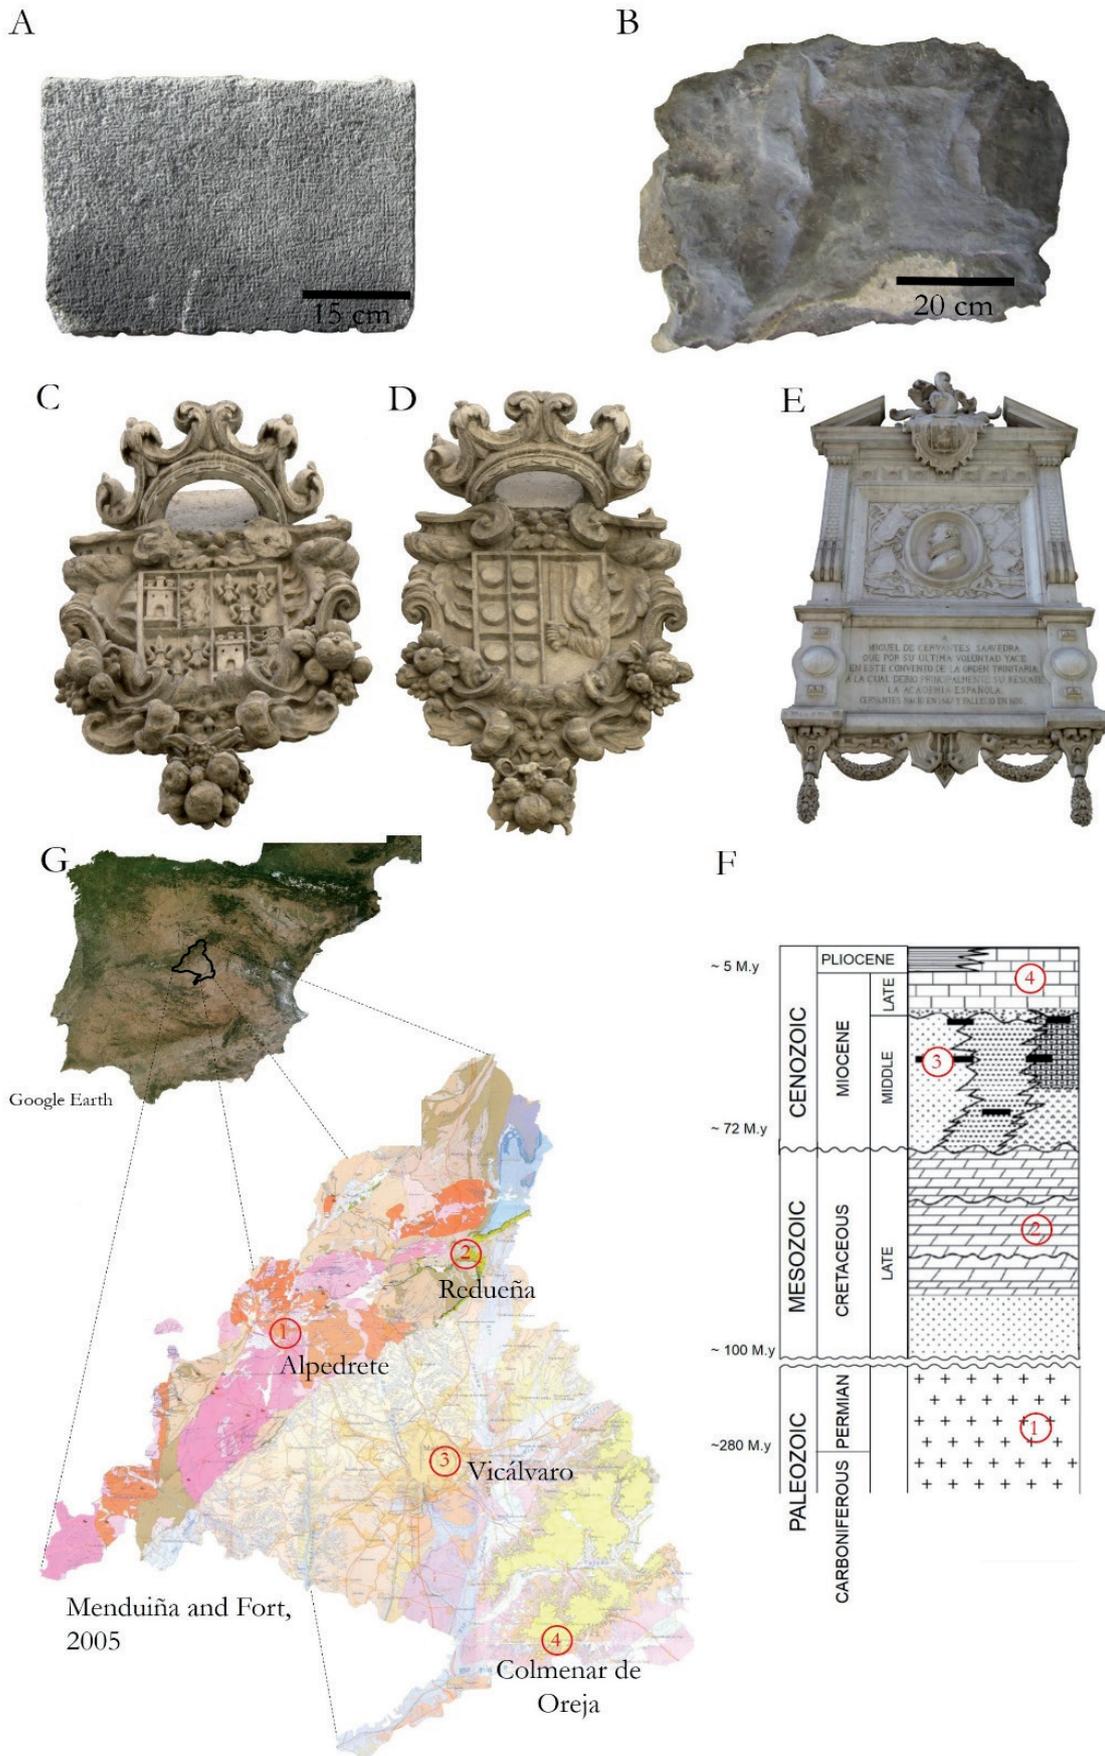
**Figure 4.-** A: Granite ashlar of the plinth. B: Rough stone of plinth flint. C and D: Lateral crowns: Miocene limestone from the Madrid Basin, Coat of arms: Cretaceous dolostone. E: Carrara marble. F: Location of the historic quarries. G: Schematic stratigraphic column of Madrid area. Showing only those units from which stones were extracted to build the convent. Modified of Fort et al. 2013.

Chromatic parameters of the CTDOSI plinth are represented in Table 1. The  $\Delta E^*$  between CTDOSI plinth granite and Alpedrete granite extracted in an active quarry is 11. Plinth granite yellow tones are due to the ashlar extracted from a shallow quarry and therefore they are more altered [Figure 3A] in addition to the decay *in situ*. Therefore the granite building is more altered than the quarry and it has more yellow tones and less luminosity. Figure 4A shows a

granite ashlar of the convent plinth with bush-hammered marks, the traditional finishing of granite ashlars in Madrid.

Flint used in the plinth [Figure 3B' and 4B] comes from quarries around Madrid, probably from Vicálvaro, at Cerro de la Mesa quarries (latitude and longitude coordinates: 40.416783, -3.590903). The rock that contains flint is a micritic limestone. Different types of flint, in colour and quality, have been identified. Silicification initially gave rise to opal, which diagenetic weathering subsequently transformed into quartz (Bustillo et al. 2012: 239).

The ornamental part of the building (coat of arms and bass-relief of the church) are carved from cretaceous dolostone [Figure 4C and D] (Tovar Martín 1974, 1990). This stone is formed by rhombic dolomite crystals. It is occasionally banded because remnants of its original depositional texture (stromatolitic structures) are preserved. The crystals are microcrystalline, equigranular (<50  $\mu\text{m}$ ) and dark, with few mottled cores. Porosity is high and poikilotopic and blocky mosaic cements predominate. The presence of localized iron oxyhydroxide deposits gives this stone its reddish colour (Fort et al. 2013: 423).

The stone used for the crowns [Figure 4C and D] is an Upper Miocene limestone from the Madrid sedimentary basin. It is classified as a lacustrine biomicrite/biosparite formed by a bioclast skeleton (40% characeae, ostracods and gastropods) and a paste where the micritic matrix (20–30%) alternates with sparitic cement (30–40%). The micrite is a cryptocrystalline mass, calcitic in composition and dark-coloured (Fort et al. 2013: 423).

The commemorative plaque of Cervantes is carved in Carrara marble from the western central area of the Apuan Alps, Tuscany region-Italy. It is a marble lithotype of homogeneous composition of highly uniform white colour, variety commercially identified as Michelangelo marble statuary. This plaque was installed in the convent in 1870 [Figure 4E].

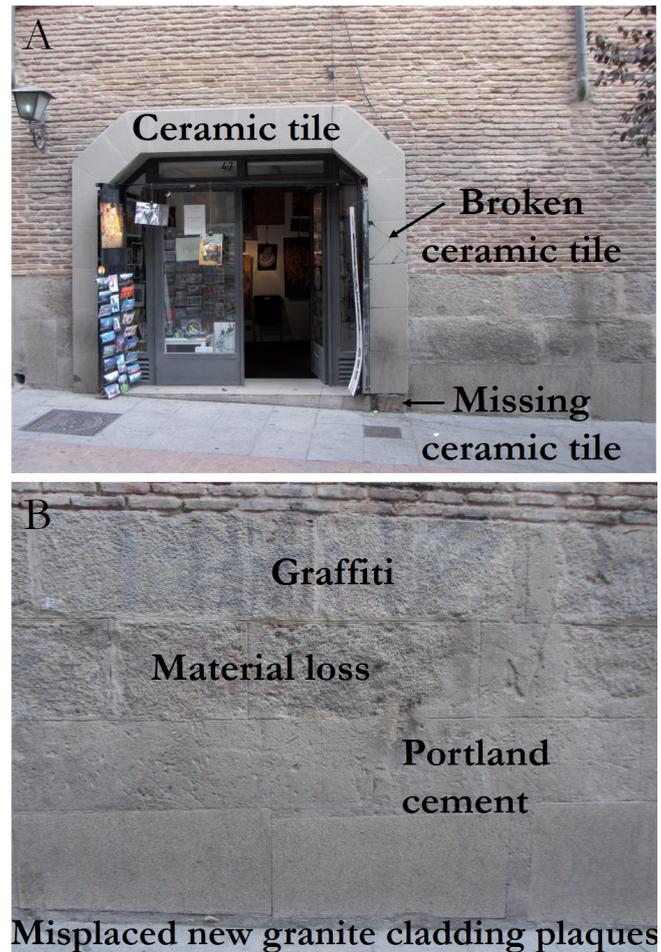
**Figure 5.-** CTDOSI plinth facing Huertas Street. A: Granite replacement by ceramic tile. B: Anthropic decay in the plinth.

The Huertas street façade has been modified. Doorways have been built by replacing original granite with lower quality artificial materials like ceramic tile. The use of Portland cement between ashlar joints and covering them may also be observed, as well as granite cladding plaques with differing dimensions to the original ashlars have been placed in the lowermost part of the plinth and graffiti were painted [Figure 5]. Architecture, restauration and the urban planning must be focused on sustainable conservation (Compitello 1999, Larson 2003).
