The Efficiency of Polymeric Coatings for the Conservation of Ancient Egyptian Wall Paintings, El-Qurna Necropolis, Upper Egypt

Hussein Hassan Marey Mahmoud

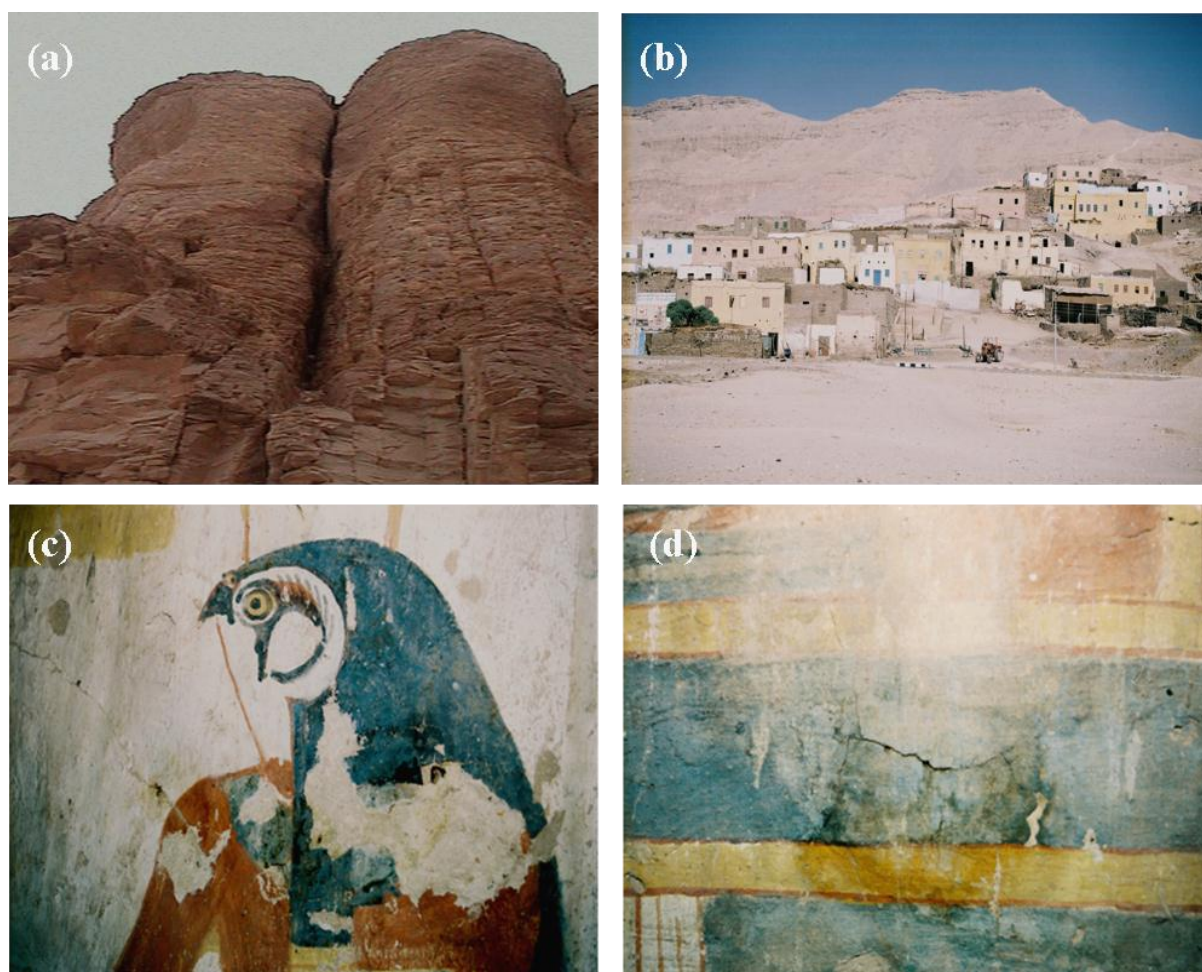
Figure 1. (a) View of the Theban Mountain, El-Qurna necropolis. (b) View of Qurnet Marai necropolis. (c) Loss of the paints and painted flakes express the state of conservation of the wall paintings at Tomb of *Ameneminet*, No. TT277. (d) Different cracks spread over the painted surfaces.

El-Qurna necropolis is located in the west bank of the river Nile at the city of Luxor (about 670 km south of Cairo). There are more than three hundred tombs belong to officials of the New Kingdom (c.1570–1070 BC) at El-Qurna necropolis (Kamil 1976). The tombs style is the cut-rock tombs in the bedrock of the Thebes Mountains. Thebes Mountains are composed of 350 meter thick Eocene marls and limestone overlying the 60 meter thick Esna shale Formation. The lower levels of the Theban Formation are composed of slightly clayey, sub-chalky limestone, which serves to enclose a few bedrock layers of flint nodules and becomes more massive at greater depths (Said 1960; Guillaume and Piau 2003). The biggest hazard to the area is the flood water that penetrates into the structures. Furthermore, the deterioration becomes more effective due to the presence of swelling clay minerals and soluble salts in the geological structure. Moreover, the water seepage from the nearby houses and the cultivated lands represent another source of saline ions which react with stone material and re-crystallize in form of different salt phases (Marey Mahmoud 2010). The decorations of the ancient tombs in Egypt are expected undergo as a result of the environmental effects, mainly, salt weathering, thermal and wet-dry cycling, in addition to the biodeterioration. Crystallization of salts is the main deterioration factor affecting in the site, crystallization of salts produces a destructive effect. Under favorable conditions, some salts may crystallize or re-crystallize to different hydrates which occupy a larger space and exert additional pressure producing cracking, powdering and flaking (Rodríguez-Navarro and Doehne 1999; Pel et al. 2002) (see Figure 1). The same salt may crystallize as isometric grains in crusts and as whiskers in fluffy efflorescence at different places on a wall at the same time or at the same place at different times (Arnold and Zehnder, 1987). A serious damage of pigments could be produced by the effect of salt ions. Chlorine plays a dominant role in the light induced blackening phenomenon of vermilion. Under the influence of light, an electron hole pair is generated and a photo-electrochemical process takes place, which enables an electron transfers from chlorine anion to mercury and from sulphide back to chloride (i.e. chlorine has a catalytic function) (Keune and Boon 2005). Moreover, damage of the wall paintings produced by swelling clays and particularly in the presence of salts is mainly resulting in form of detachments, disintegration of the inner structure and micro/macro cracks on the painted surfaces.

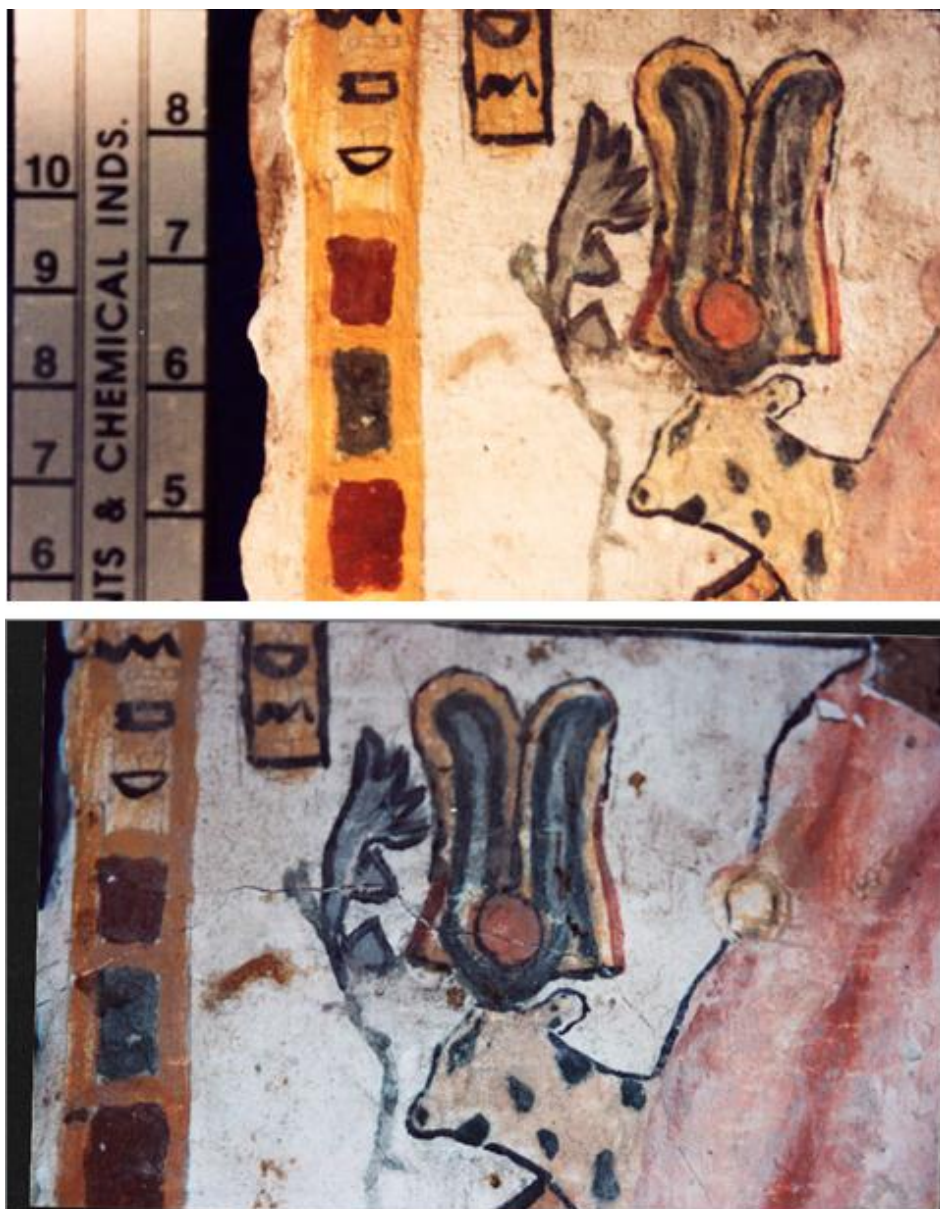
Figure 2. Laboratory models before and after artificial aging

To study the durability of consolidation materials against salt weathering, the laboratory samples were treated with a solution of sodium chloride (NaCl, 10%), this hygroscopic salt is the most permanent salt phase detected in most of the stone monuments and wall paintings in Egypt. The stone samples were coated with paraffin wax in all the sides except of the top and the bottom, and then they lied on wooden panels and immersed in the saturated solution for 16–18 hours. After this step, samples were removed and let to dry in room temperature then they were put in an oven in temperature reached to 60 °C for 8 hours with intervention for 2–4 hours in room temperature. This procedure was repeated for 17 cycles. Figure 2 shows laboratory models before and after artificial aging.

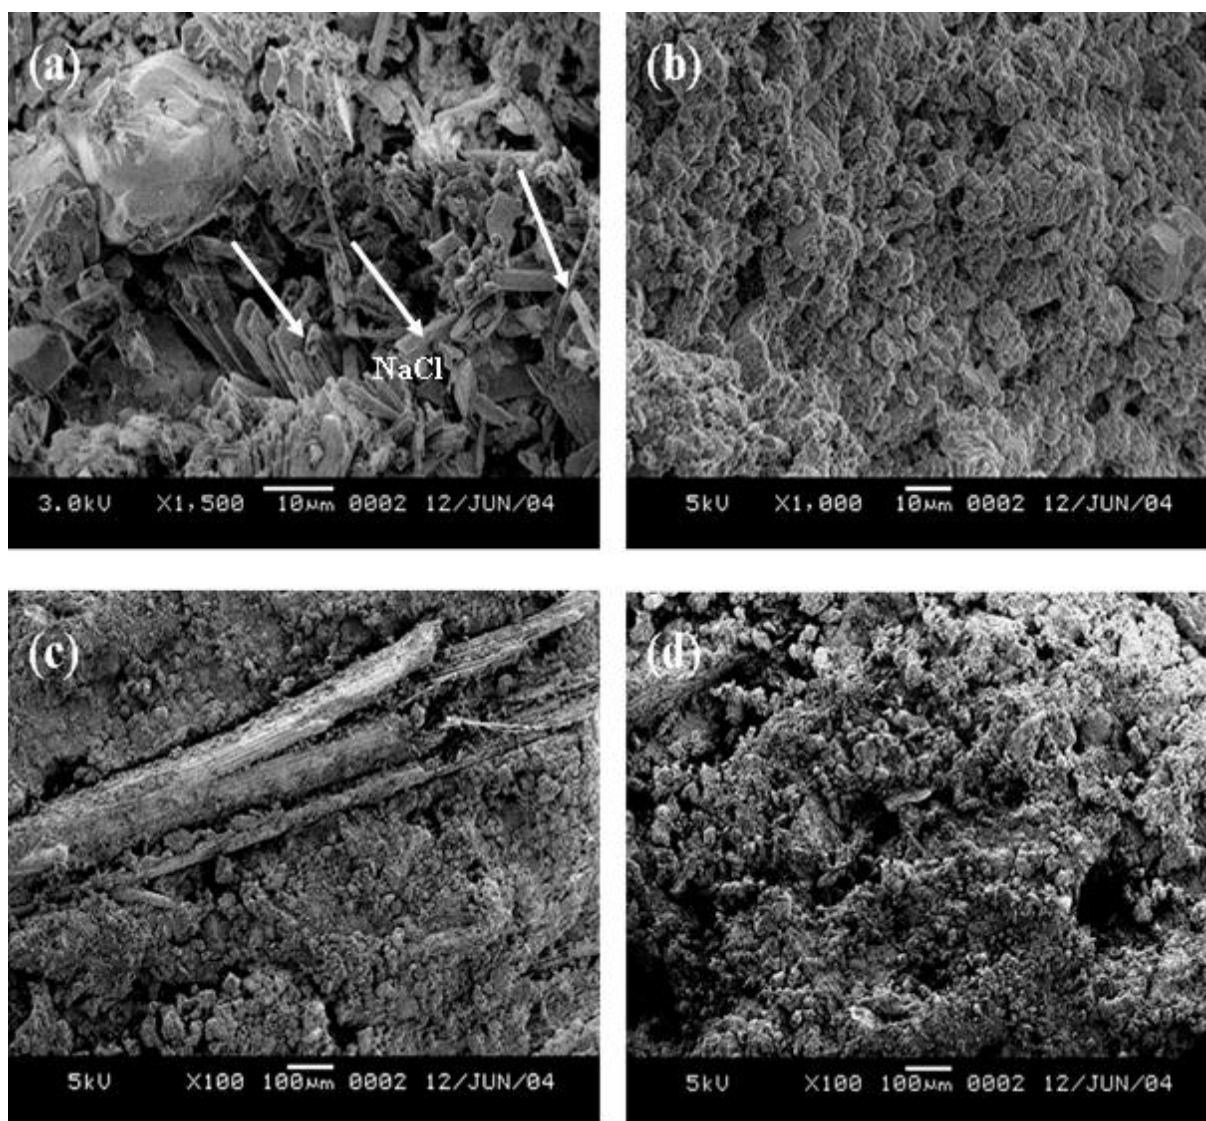
Figure 3. SEM micrographs of damaged stone and plaster layers. (a) Weathered stone and crystallization of many salts such as halite. (b) The loss of cohesion of the stone matrix due to the weathering process. (c) Chopped straw fibres beneath and on the surface of the clay render. (d) The precipitation of salt layer on the surface.

Figure 3 shows SEM micrographs obtained on the damaged stones and plaster layers. SEM investigation of the damaged stone samples showed the crystallization of different salts and mainly sodium chloride (halite) in the stone matrix causing the disintegration and decomposition of the stone (Fig. 3a). Moreover, the SEM micrographs showed the erosion of calcite crystals due to weathering

mechanisms, and also, crystals of clay minerals were also observed in structure of the stone (Fig. 3b). The SEM micrograph obtained on the clay render showed the presence of chopped straw fibres beneath and on the surface (Fig. 3c). The investigation of the damaged plaster layers showed the loss of cohesion between particles and the crystallization of salts, mainly gypsum and anhydrite, in form of dense coat covers the surface (Fig. 3d).

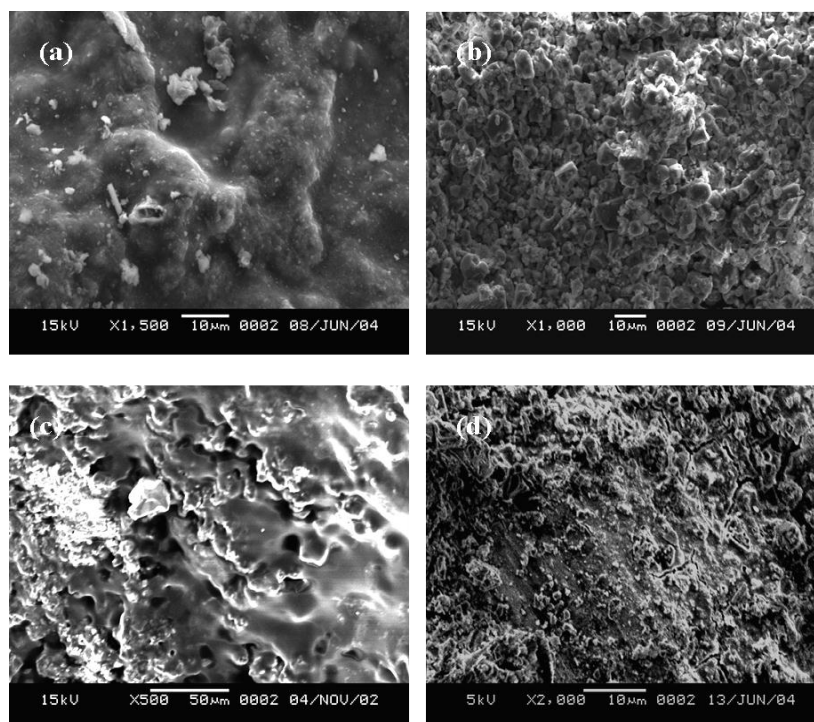
Figure 5. SEM micrographs of stone samples after treatment with the consolidation products. (a) Sample treated with Wacker VP 1311. (b) Sample treated with Wacker OH. (c) Sample treated with Paraloid B67. (d) Sample treated with Paraloid B82.

Figure (5) displays SEM micrographs obtained on the treated samples. Tiny pieces from the inner areas of the consolidated models were cut and investigated (the average depth of cutting from the outer surface of samples were approximately 23mm). SEM investigation is reported to show the surface morphology of the samples before and after the application of consolidation products. In the case of Wacker VP 1311, the water emulsion can create "islands" in the surface and a dense coat of the resin was formed between the crystals (Fig. 5a). After treatment with Wacker OH, it was observed that the microstructure created within the stone by the deposition of the polymeric material formed a homogenous film and a new network was created, also the cohesion of grains was increased in addition it smoothed the roughness of the surface (Fig. 5b). The main effect after the acrylic co-polymers (Paraloid B67 and B82) was the formation of a dense coat covers the grains and affects seriously the porosity of the stone. Using Paraloid B67, a dense surface layer was formed that alters dramatically the stone's morphology; the occlusion of pores with diameter in the range of few microns is observed, in addition, micro-cracks were also observed (Fig. 5c). Paraloid B82 deposited between the grains and grains are covered with the polymeric material (Fig. 5d).

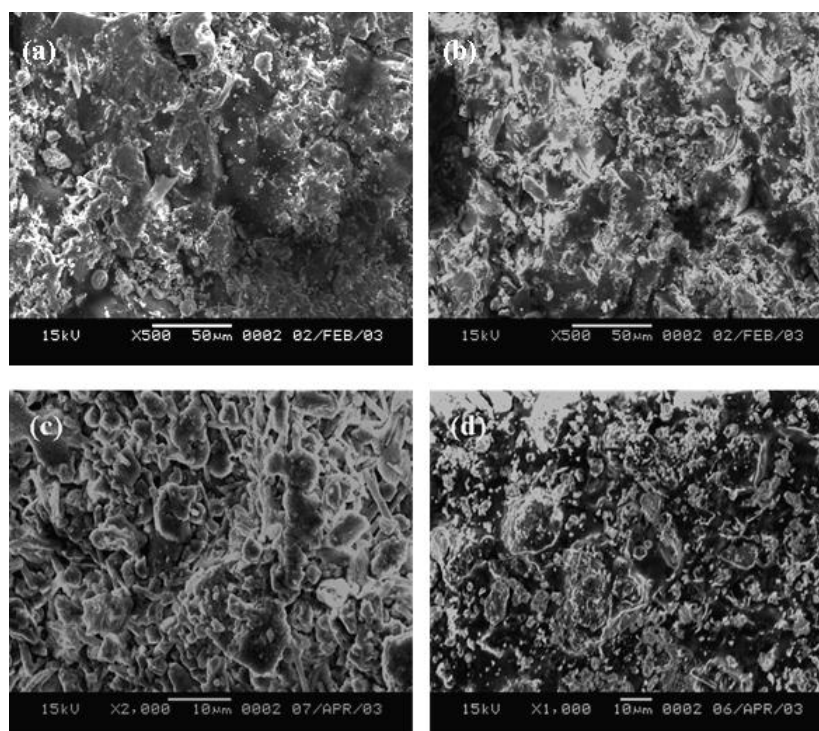
Figure 6. SEM micrographs of the treated stone samples after salt weathering. (a) Sample treated with Wacker VP 1311. (b) Sample treated with Wacker OH. (c) Sample treated with Paraloid B67. (d) Sample treated with Paraloid B82.

After salt weathering, samples were subjected again to color measurements to detect any change in their appearance. The chromatic variations induced by the artificial ageing on the treated surfaces showed that the most significant decrease in brightness was observed with samples treated with Paraloid B67. Other chromatic variations include a slight increase in red (Δa^*) and yellow hues (Δb^*) were also detected; the highest increase in the yellow hue was observed in the case of Paraloid B67 and Paraloid B82. Treatments with Paraloid B67 changed the color more than other consolidants, while the least color change was induced by Wacker OH. The order of the results from most color change to the least was: Paraloid B67 ($\Delta E^* = 5.32$), Paraloid B82 ($\Delta E^* = 4.21$), Wacker VP1311 ($\Delta E^* = 3.16$) and Wacker OH ($\Delta E^* = 2.8$). After salt weathering, the porosity of samples was increased (Fig. 4d), it reached for samples treated with Paraloid B82 to 3.1%, for Paraloid B67 =2.98%, for Wacker VP 1311 =3.67%, and for samples treated with Wacker OH =3.77%. The water absorption of treated samples decreased significantly after treatment, samples treated with Paraloid B82 =3.49%, samples treated with Paraloid B67 =2.52%, samples treated with Wacker VP 1311 =3.72%, samples treated with Wacker OH =2.62%. The mechanical properties after salt weathering were slightly decreased (Fig. 4f). Samples treated with Paraloid B82 showed a dry compressive strength =140 kg/cm², while samples treated with Paraloid B67 showed a dry compressive strength =135 kg/cm². Silane-based products of Wacker OH showed a dry compressive strength =132 kg/cm², while Wacker VP 1311 showed a dry compressive strength =125 kg/cm². SEM investigation was used once again to examine the stability of the consolidation products after salt weathering (Fig. 6). After salt weathering, the samples showed modifications in their morphology. In the case of Wacker VP 1311, the consolidating material has surrounded the particles and coated the surfaces of the pores (Fig. 6a). Wacker OH was mainly deposited to the inner pore wall leaving a smooth surface on the grains (Fig. 6b). Sample treated with Paraloid B67 showed that the pores are still mostly filled with the polymeric material (Fig. 6c). The surface of the sample treated with Paraloid B82 became more smoothed and the polymer materials still covering the surface with a dense coat (Fig. 6d).
